REPORT
TO THE
SOUTHERN GRAMPIANS SHIRE COUNCIL
MASTER PLAN
FOR THE
HAMILTON REGIONAL LIVESTOCK EXCHANGE

KATTLE GEAR AUSTRALIA PTY LTD

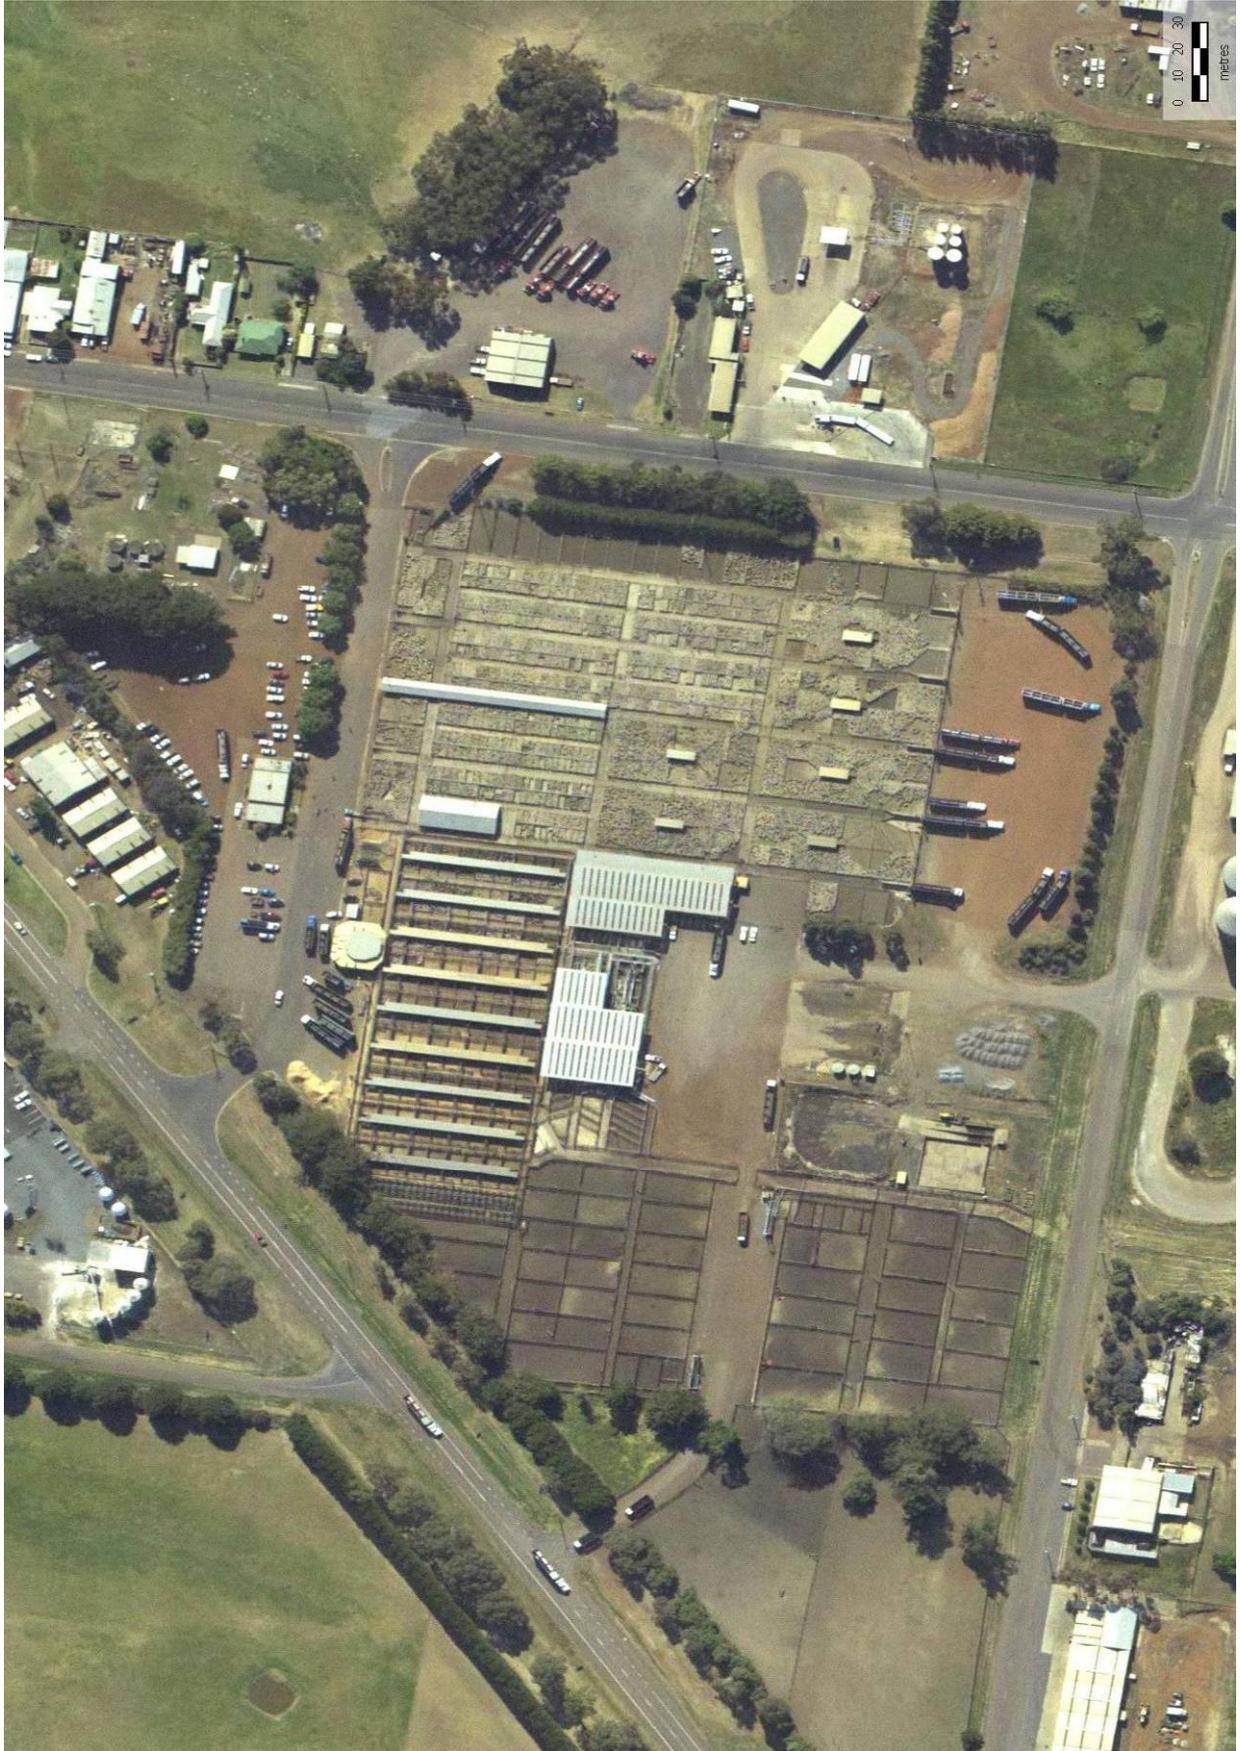
Figure 2 AERIAL PHOTOGRAPH OF HAMILTON REGIONAL LIVESTOCK EXCHANGE (HRLE)

The major features of the yards area include the sheep yards, earthen sheep delivery pens, cattle yards including covered receival, weighing area and selling pens, the rotunda selling area, access roads, truck and car parking, cafeteria and offices, maintenance depot area and truck wash and effluent treatment area. Figures 1 and 2 details the layout of the complex which exists currently.

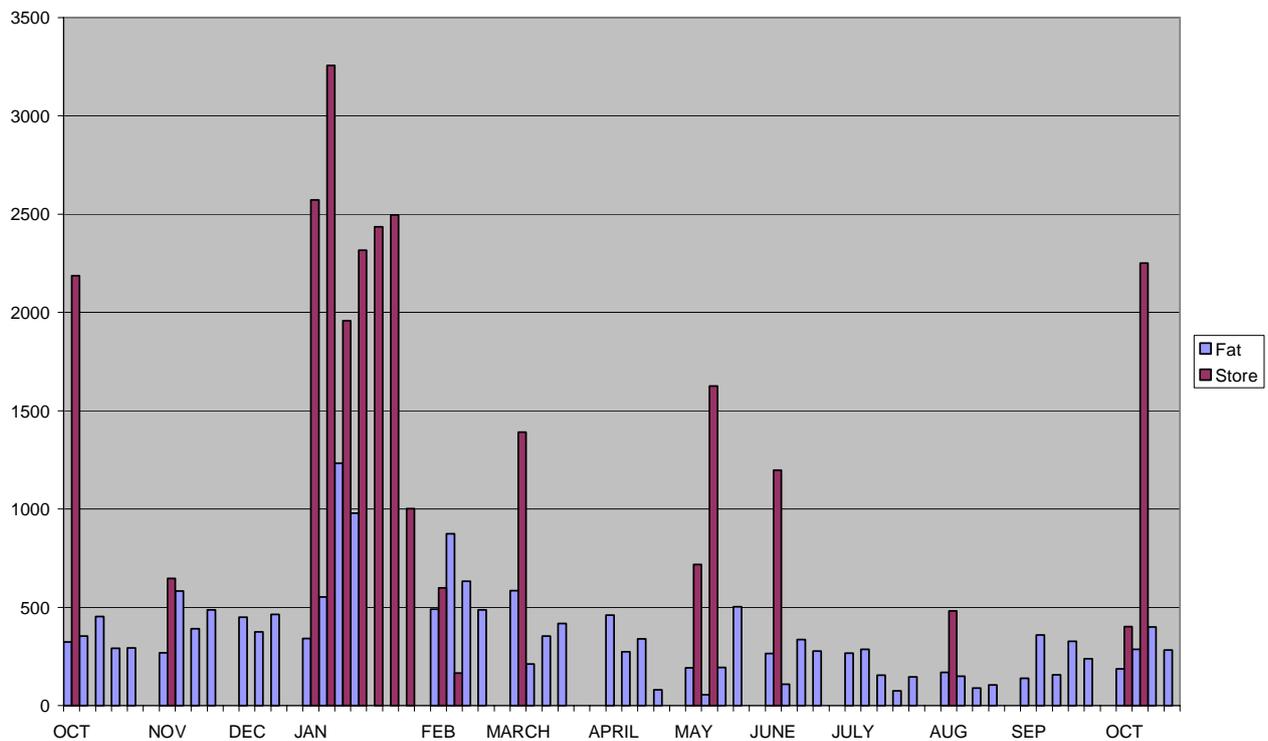
Figure 5 HAMILTON LIVESTOCK EXCHANGE CATTLE THROUGHPUT OCT 2010 TO OCT 2011

Figure 5 shows that only one fat sale in 2010 – 2011 exceeded 1,000 cattle. Fat cattle need to be displayed with less density to allow the meat buyers to more easily ascertain value and condition, however, the cattle yards are well capable of handling these numbers.

The store cattle sales are of greatest importance to the animal throughput of the yards with seven sales exceeding 2,000 head, five of these in the month of January. Store sales can successfully sell cattle in higher densities, but do stretch the resources and ability to read and process NLIS numbers and data. However, it is considered to be an acceptable situation when the capacity is only required for 10% of the sales.

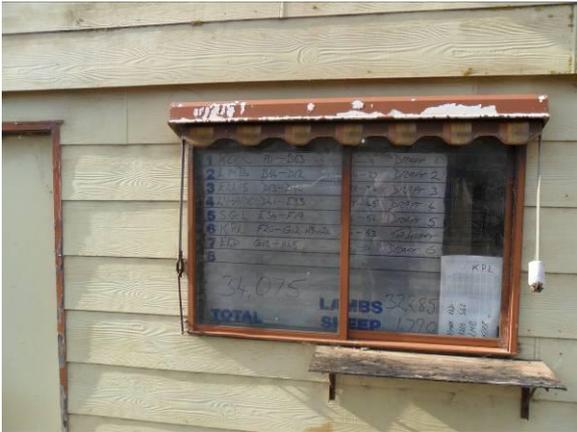
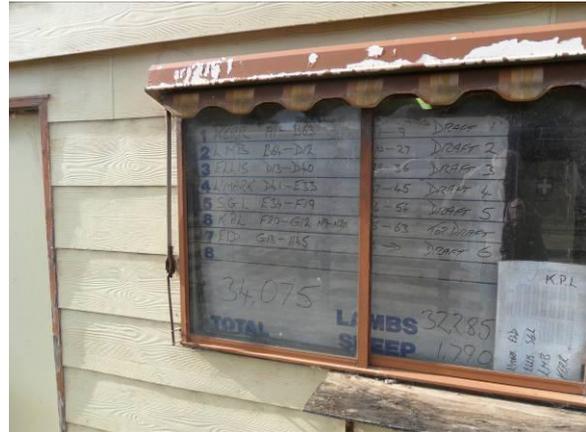
The pen allocation sign, together with order of sale information could be more legible.

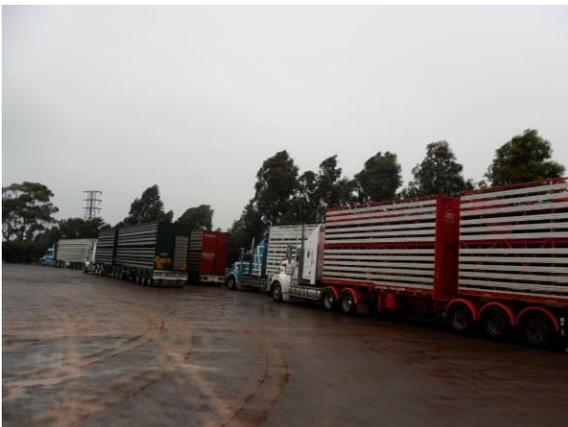
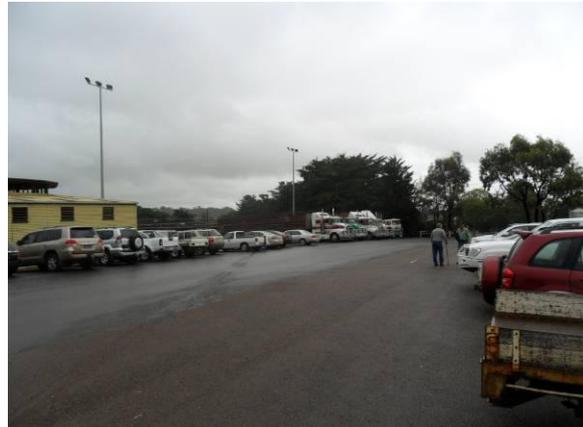
The attached photo shows 'B' doubles lined up or parked in the sheep unloading manoeuvre area. There was some disquiet from drivers that this practice restricted backing access for 'B' doubles to the multi-deck ramps.

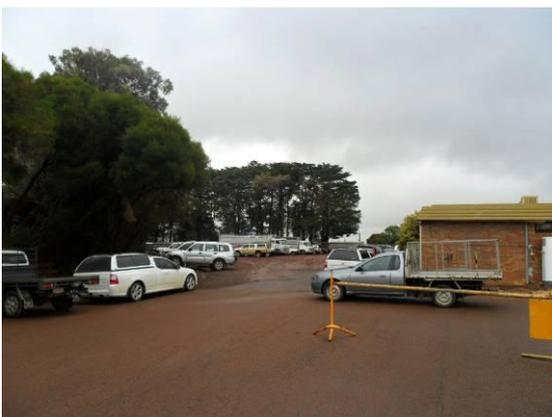
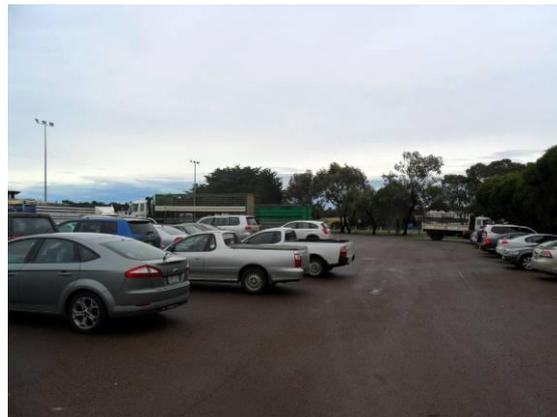
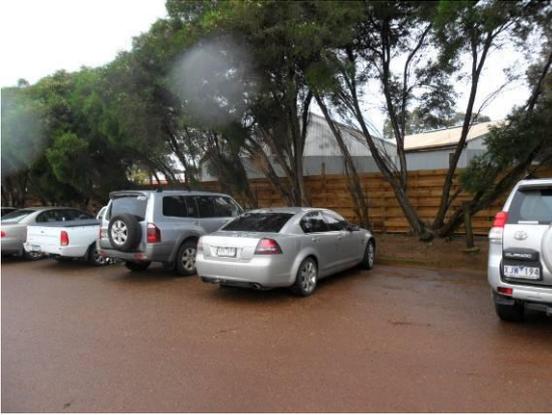
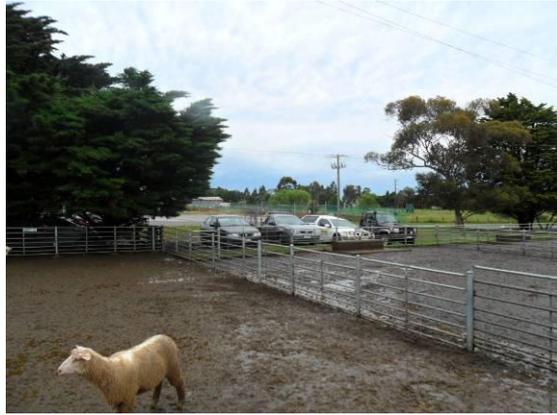
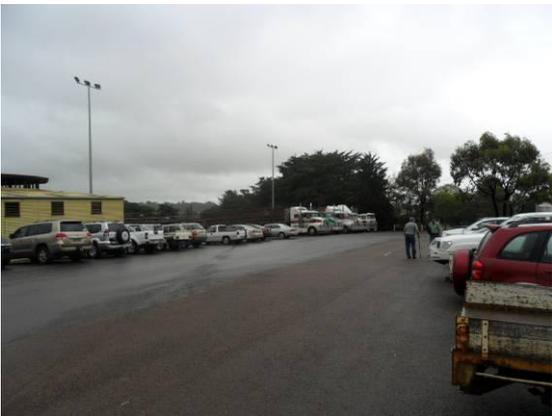
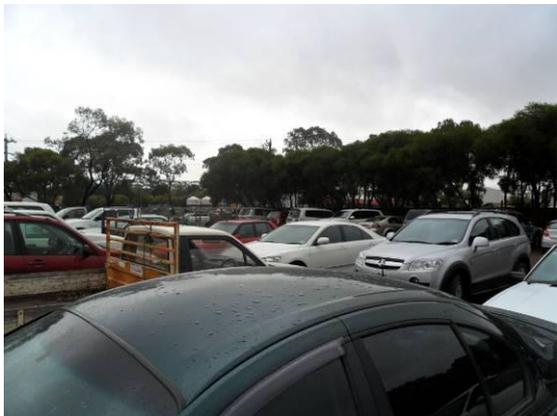
Small vehicles are parked predominantly in the sealed areas around the canteen, although some body trucks and articulated vehicles were observed in these areas as well. Although parking was at a premium for the weaner sales and sheep sales, everyone was able to be accommodated. However, much of the parking in this area was inefficient and haphazard. The mixed parking of light and heavy vehicles was also hazardous.

If the recommendations of this master plan were adopted, parking availability will be reduced in the northern car park. To ensure sufficient capacity is provided, the following strategies should be adopted.

- Extension of the sealed areas in the north east corner of the park and the provision of lined parking bays. This is estimated to provide sufficient additional spaces to accommodate demand at large sales.
- Provision of dedicated truck parking in the north west corner of the northern park, and on Port Fairy Road reserve, and an additional area below the truck wash which will need to be formed and stabilised. Figure 7 in the appendix describes how parking bays should be defined.

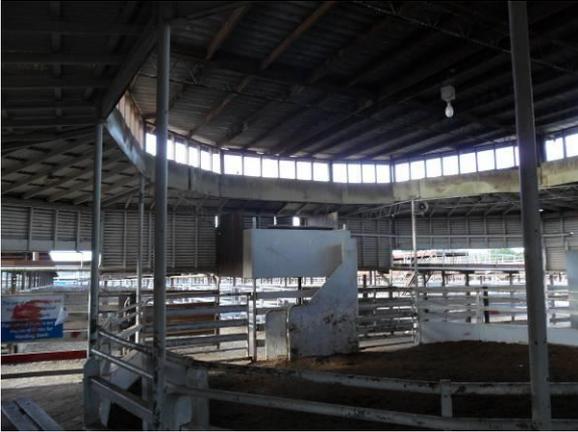
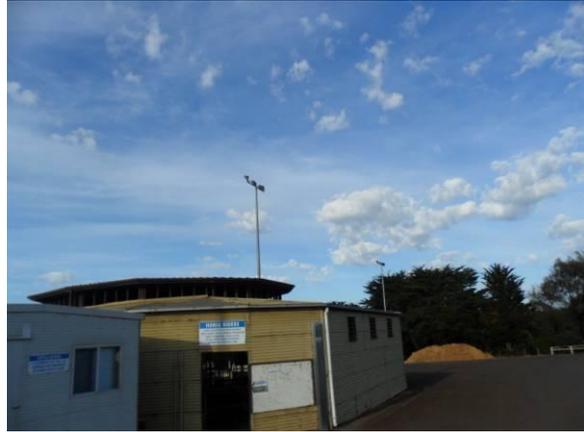
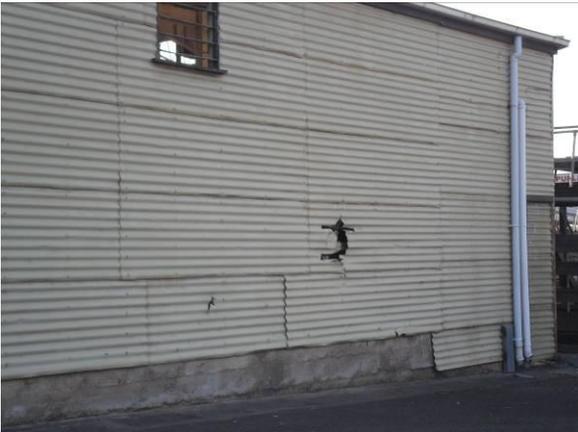
- The rotunda is mainly used for monthly horse sale.
- Structurally, the building appears in good condition with good lines and plumbing in good order.
- Seating is adequate
- The fence around the ring is of inadequate height to conduct a bull sale
- If this is a required function of the facility, the height needs to be lifted to a minimum of 1650mm at the top rail.
- The stakeholders meeting indicated that the building was as ‘eye sore’ and required maintenance, and a spruce up.
- The relocation of the manager’s office may create an opportunity to construct an architecturally sympathetic structure relative to a renovated rotunda structure.

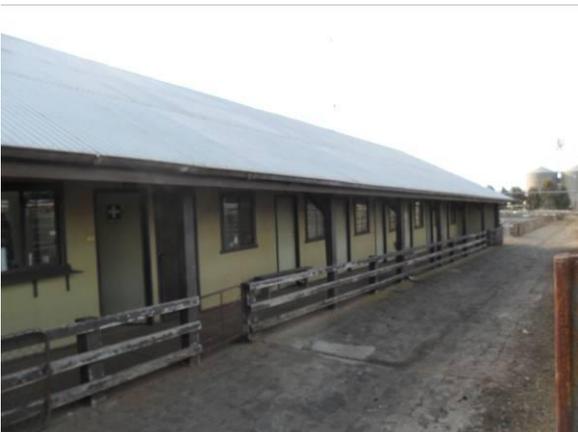
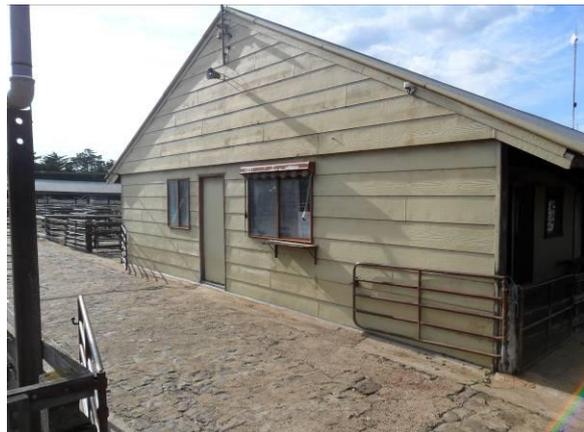
The existing offices are situated in a timber and weatherboard building at the north west corner of the sheep yards opposite the canteen. The building is old and in need of aesthetic maintenance.

Whilst considered adequate, and well positioned by the manager, it is situated in prime space for the sheep yard reconstruction.

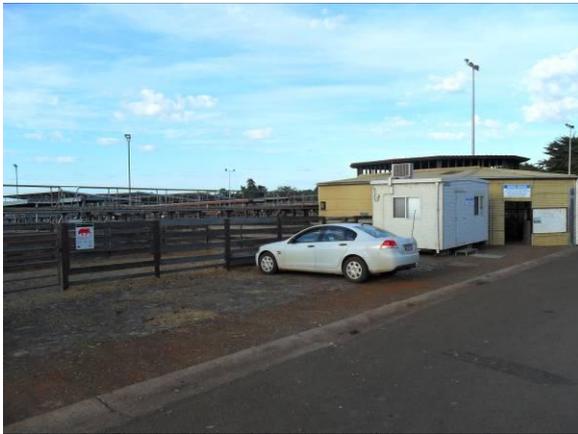
The agent association and their secretary currently utilise a relocatable building on the north side of the cattle yards between the rotunda, and ramps A and B.

It is proposed that a more permanent office structure to accommodate the manager, sale day administration, agents, secretary and saleyards staff meal room and meeting place be constructed in the space between the rotunda and ramp A. The building should be sympathetic to the style and architecture of a renovated rotunda. The stakeholders meetings did not request more individual offices for agents. A concept of the elevations and layout of the new office is included as Figure 8 in the appendix.

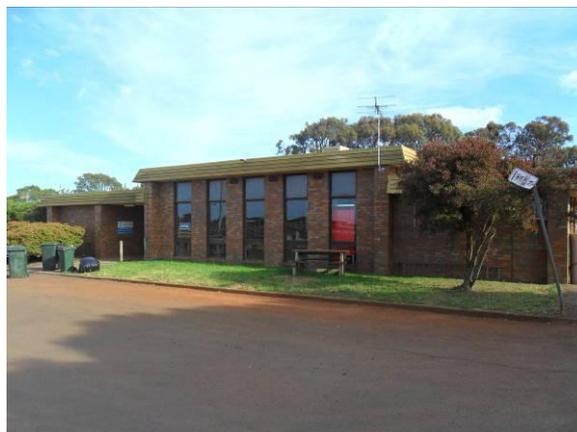
The canteen and amenities building functions extremely well. It contains one large general eating area and a well equipped kitchen. The area is leased to a private operator, and the standard of food and service is excellent, and well patronised.

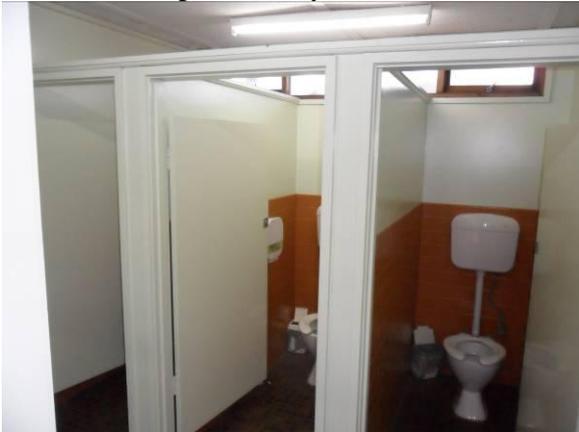
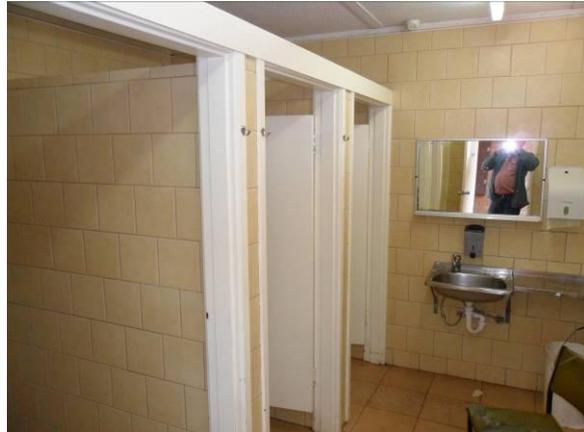
The area to the western end contains female and male toilets, and showers for the use of stakeholders, particularly truck drivers.

The building is well positioned, with easy access from both sheep and cattle yards, the rotunda and the northern car park.

However, although the building appears to be structurally sound, it is aesthetically and superficially looking in very poor condition.

- Rotting timber window frames
- Broken and unattached eaves, possibly caused by internal gutters, and poor maintenance
- Fascia's requiring painting.

The windows could be progressively replaced on non-sale days in the quieter periods without any detrimental effect.

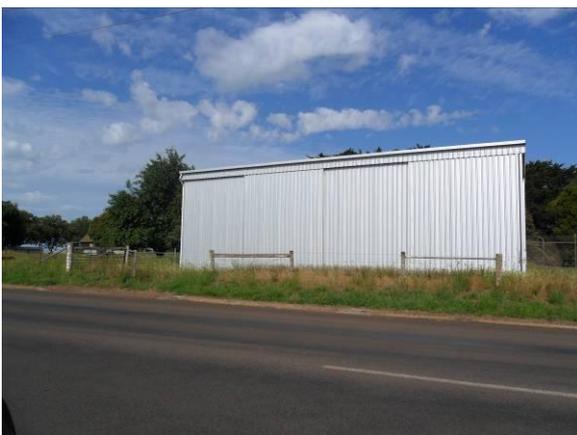
- A fully enclosed modern fodder shed.

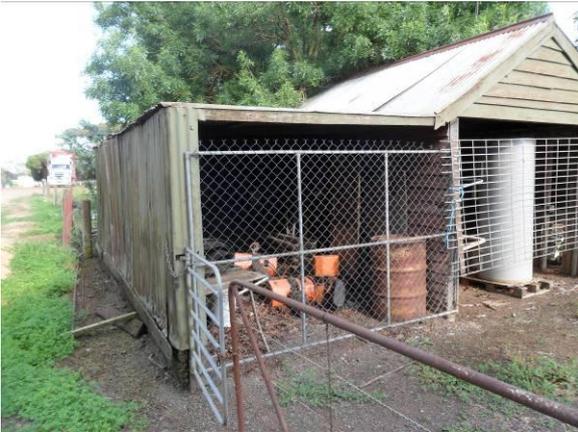
- The old timber structure which will need to be demolished to allow for the realigned access.

- Additional storage capacity will need to be provided under cover for various machinery and hoses if the existing office and storage area at the north end of the sheep yards is removed.
- A 12 metre strip will need to be taken off this area on the southern end to provide for a new access to Port Fairy Road. This more northerly access will allow the 'B' doubles utilising the new northern ramps in the sheep yards to manoeuvre more effectively. Some trees would have to be removed.

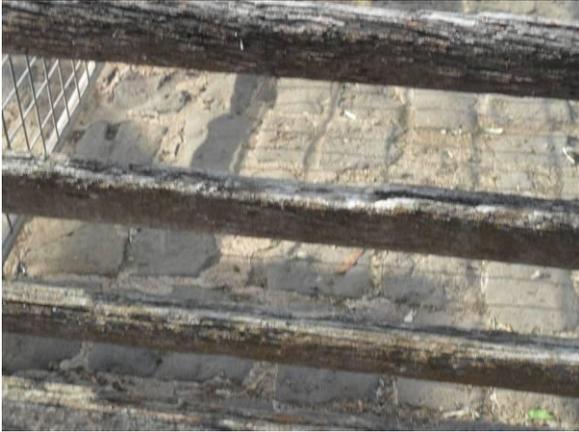
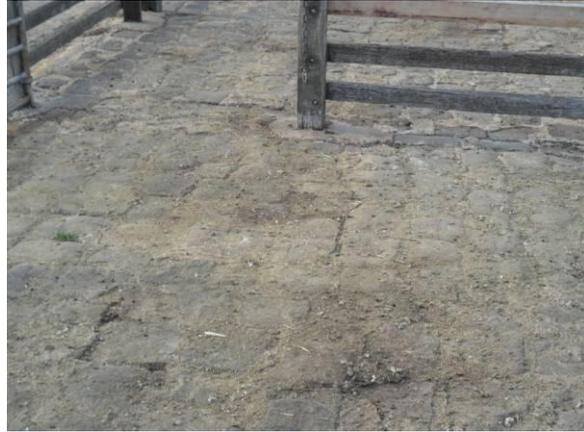
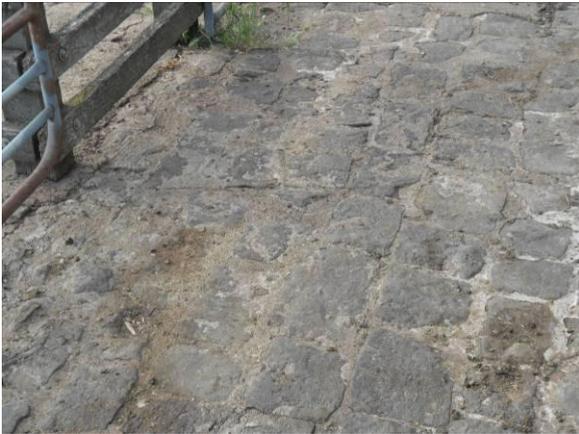
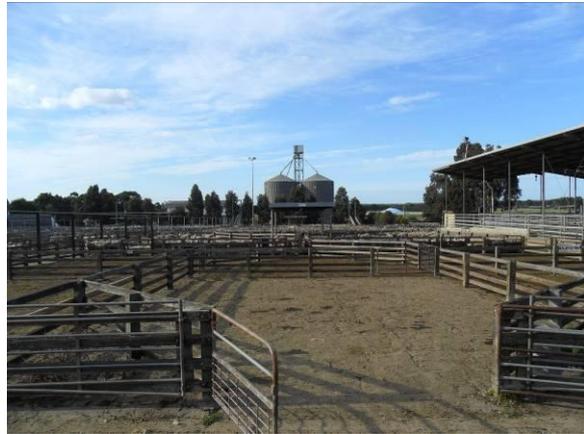
The sheep yards suffer from being constructed on a narrow constrained site, and what appears to be a haphazard development over a long period. Although in the order of one million sheep and lambs are sold in the yards annually, there is only 11 sales where the yardings are greater than 25,000 head. The concerns for the yards and stakeholders include:

- OH&S issues with walkways, walkway access and uneven surfaces.
- Inefficiencies for cleaning, maintenance and the labour requirements in the old yard design.
- Poor presentation of stock because of narrow fronted selling pens, and lack of cleaning time in busy periods.
- Uneven surfaces and weathered old timber yards.

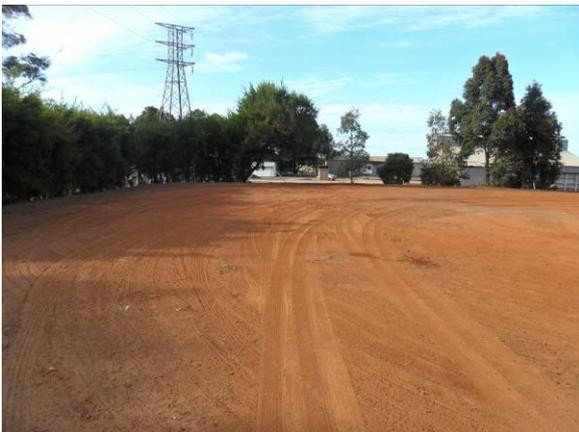
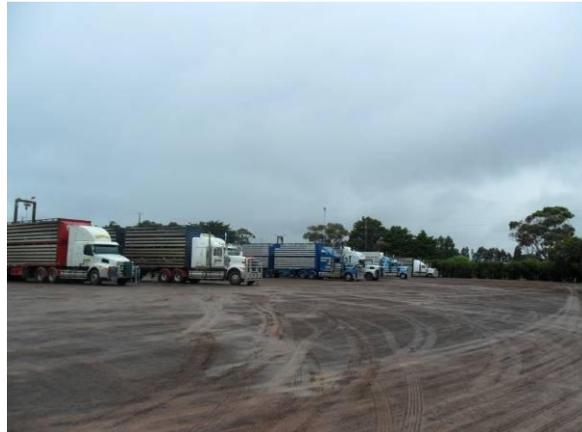
The majority of unloading occurs at the five modern 4 deck ramps situated at the southern end of the yards. The truck manoeuvre area is expansive, but can still get congested in large sales due to 'B' doubles parking on the southern side of the manoeuvre area.

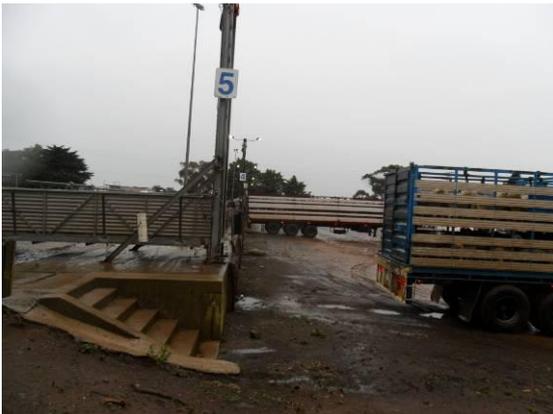
To access the ramps, a 'B' double generally drives along the southern boundary and does a 'u' turn on left hand lock to enable the vehicle to back into the ramp on right hand down. The manoeuvre area is sloped away from the yards, which is not ideal. Well designed modern facilities have this area sloping back to the ramp, which enables a 'B' double in particular to roll back to the ramp, rather than powering up a slope.

A further issue is ramp orientation which is at 90degrees to back in. Modern layouts provide angled ramps, which reduce the angle which a truck needs to back through. This reduces damage to the road from screwing, bogies, and facilitates easier backing.

The benefit of ramp realignment may not justify the required expenditure. The consultant estimates the cost of realigning each ramp to be \$7,000. This process would involve moving and extending the columns of the ramps, installing new footings, extension of the power, and moving of luminaries.

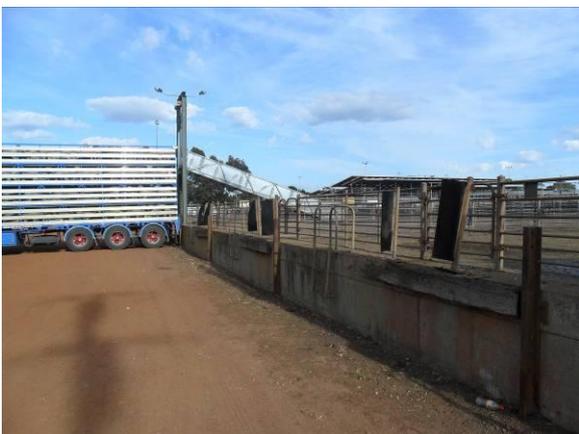
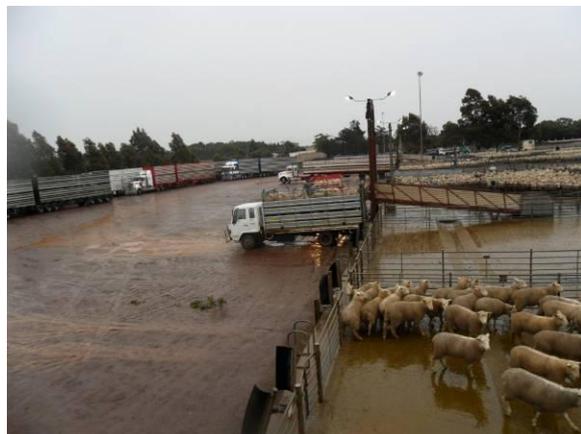
The five existing ramps are in excellent condition, with safety catches in good working order.

Between these ramps are a total of twelve body truck dumps.

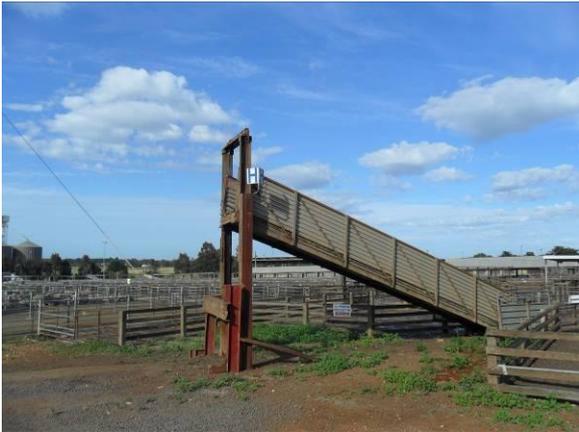
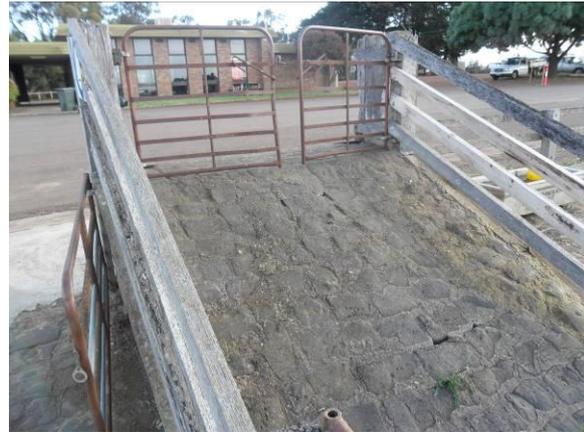
At the northern end of the yards there are three small dumps for farmer's lots in body trucks and an adjustable ramp (H) facing the Port Fairy Road. All are marginal in condition and would be replaced in a redeveloped sheep yard.

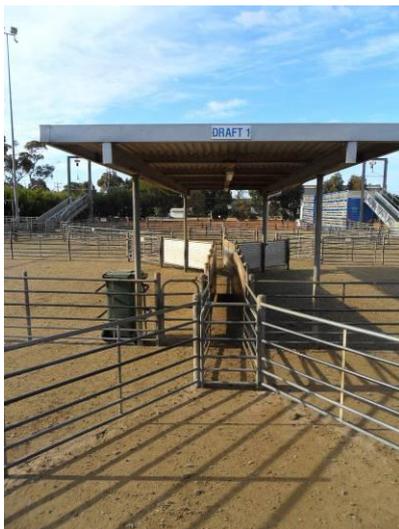
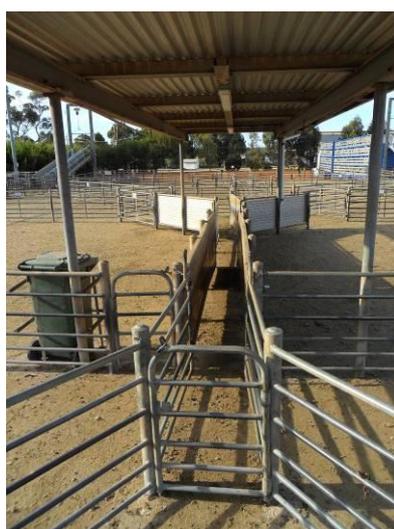
This area of the sheep yards handling system takes place at both the southern and northern ends of the yards. The layout and drafts are traditional with southern drafts 1 to 4 in good condition. The traditional drafts require high labour handling input and contain large pens that are not often fully utilised. The draft areas are covered and well illuminated.

Drafts 5 and 6 are nearing the end of their effective lives, and due to the narrow nature of the yards, will preferably be replaced by new bugle drafts at the northern end of the yards in any redevelopment. The position of these old drafts to the north of drafts 3 and 4 is very inefficient, as it means drafted groups from draft 3 and 4 have to move a long way. The existing northern receive and draft yards are old and require replacement. The position of drafts 5 and 6 compromises sheep flow from drafts numbers 3 and 4 to the selling pens.

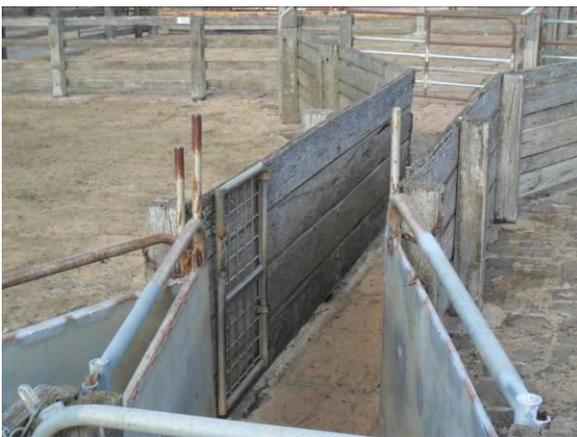
At the northern end of the yards, there are two small old wooden drafts. One is utilised almost exclusively by KPL, and the other as a second draft by one of the larger sheep agents. These are old and inefficient, with weathered timber requiring replacement.

The proposed redevelopment of the sheep yards will provide five new, efficient bugle drafts at the north end, together with 25 flexible, full sized deck receival/delivery yards. The yards will have two way gates at both the entry and exit, and two internal dividing gates to ensure small lots, or lots which are required to be kept separate take up smaller areas.

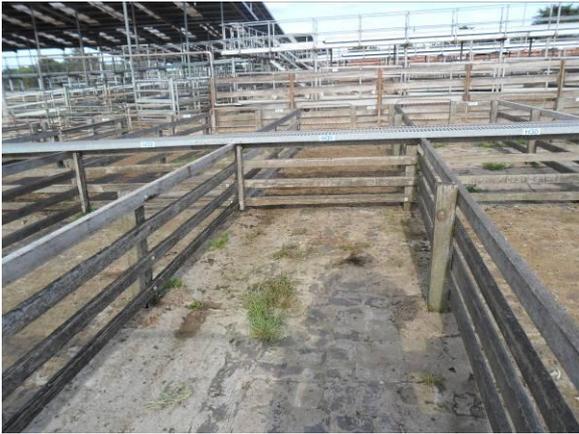
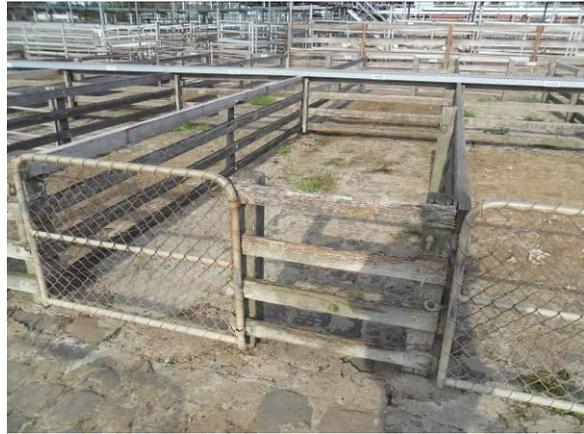
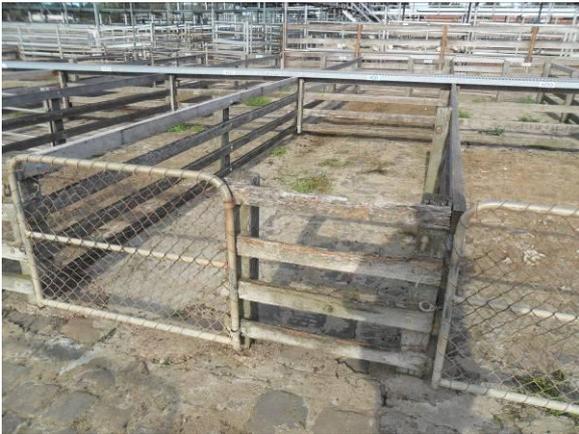
- Entry gates do not interfere across the laneway, and require greater labour input to pen up sheep.
- The narrow front of the pen dimension e.g. 2 x 5m, 2.4 x 5m in all cases was criticised by all meat buyer respondents as access to view the stock being offered is very restricted. Modern selling pens are wider in the laneway dimensions.
- The pens are solid fenced on three sides. Modern saleyards have gates on three sides to allow for pens to be enlarged to sell larger lots and to allow the pens to be opened up for efficient mechanical cleaning.

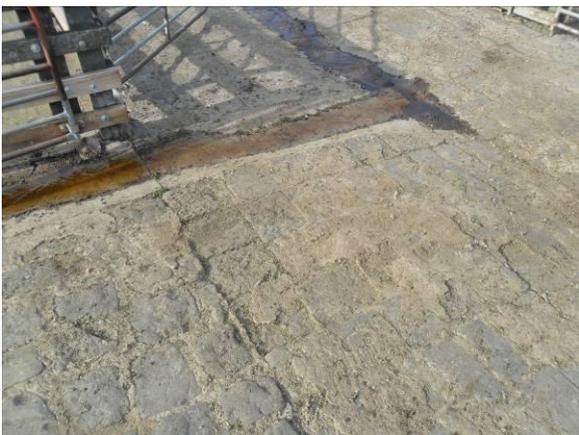
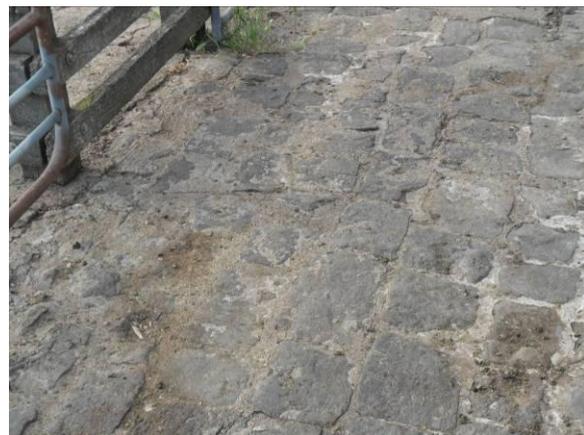
- In addition the older pens H1 to E41 (160 pens) have very weathered timber rails and posts and only 1.2m entry gates. This area also has a poor yard surface with mortar covered blue stone pitchers. (there are approximately 46,000 blue stone pitchers in this area which could be sold in the event of rebuilding).

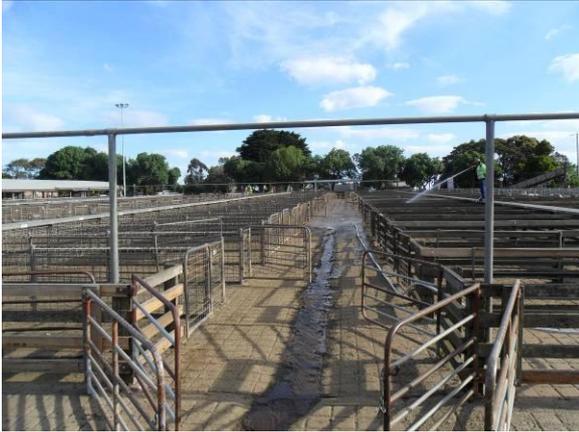
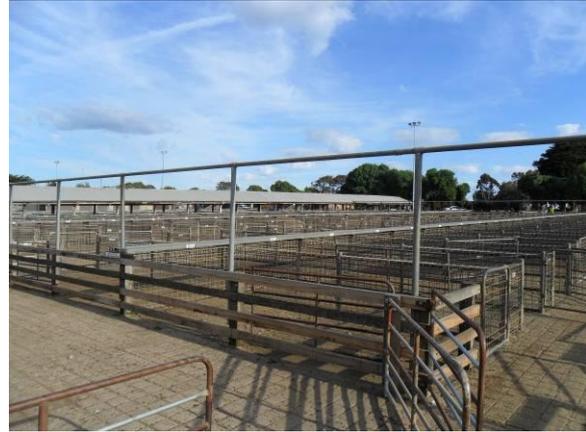
- The selling pen block from D18 to A1 is constructed from ARC mesh and is in good condition, although operationally flawed. The yard surface in this area appears to be contiguous concrete and is in good structural and functional condition. The surface would be re used in any redevelopment.

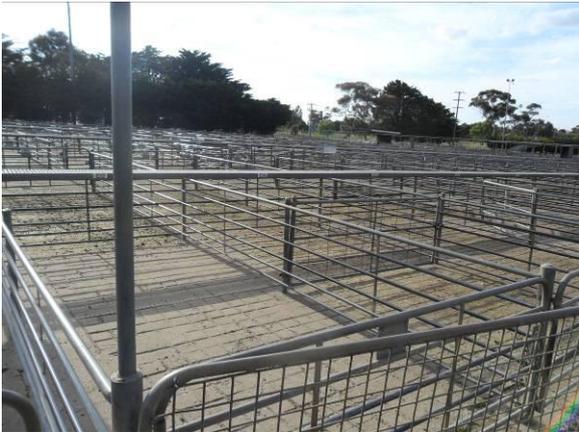
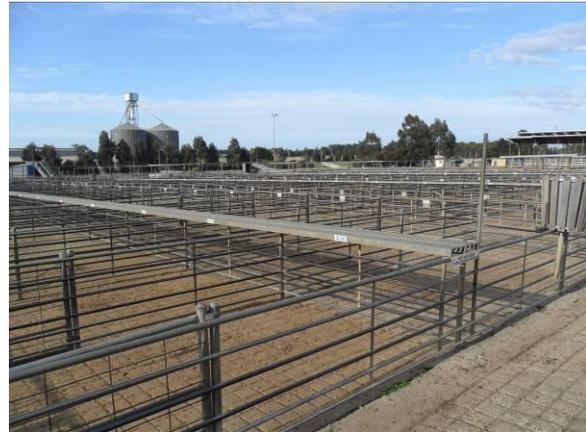
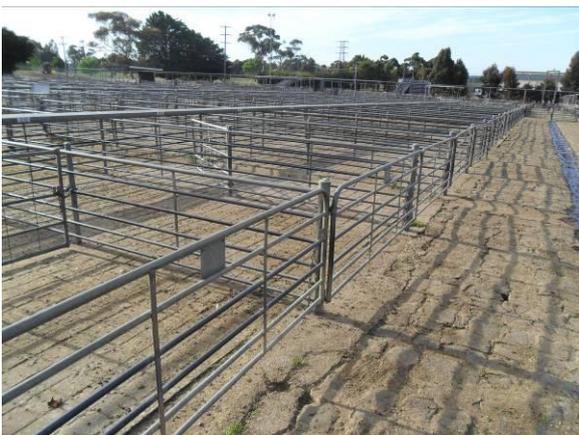
- The selling pen block from D1 to A40 (136 pens) is the most recent addition to the selling pen capacity. The yards are constructed of 6 rails of galvanised pipe (1x25NB, 5x20NB) with 32NB posts. The gate is full width but does not interfere across the lane. The yard surface is a good compromise between animal footing and ease of cleaning, and is in excellent condition.

This photograph shows a pen divider cutting the pen in two for small lots. This is not a fair presentation of stock as there is no buyer access to the back pen.

The modern layout proposed for the sheep yard redevelopment allows for pen dividers in half of the redeveloped pens which allows a 5.6m x 2.8 pen to be divided in two if required, thus providing excellent presentation of all stock.

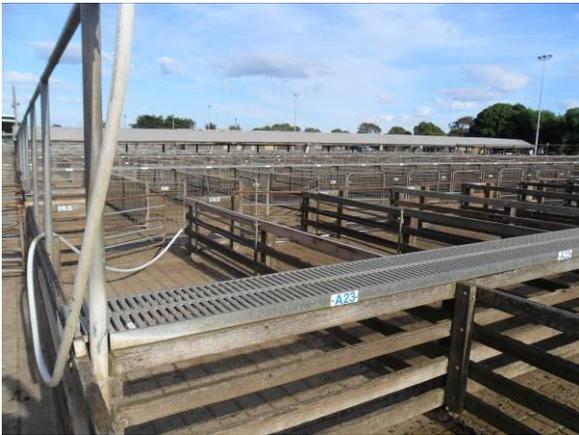
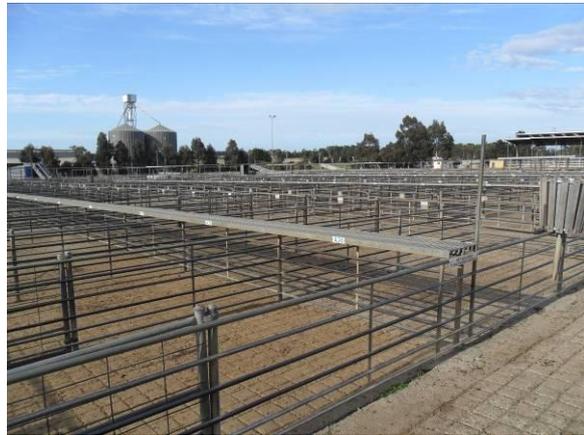
The auctioneers walkways are elevated (approximately 1100mm high). The walkway is constructed from 2 runs of interloc grating for a total width of 460mm. The walkways are in good condition but do not meet Australian Standards (AS 1657 – Walkways, stairs and ladders).

The cost of adding stanchions, kick rails, and hand rails to these walkways is estimated at \$90,000. There is 567 metres of these walkways and they represent a very significant risk for the users and for council. Compliant access ladders are also required.

The modern layout proposed has a narrow auctioneers laneway at ground level, which has no falling risks and has been endorsed during stakeholder meetings by the users.

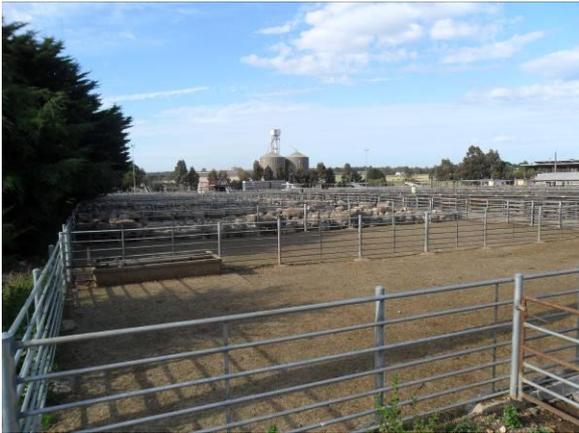
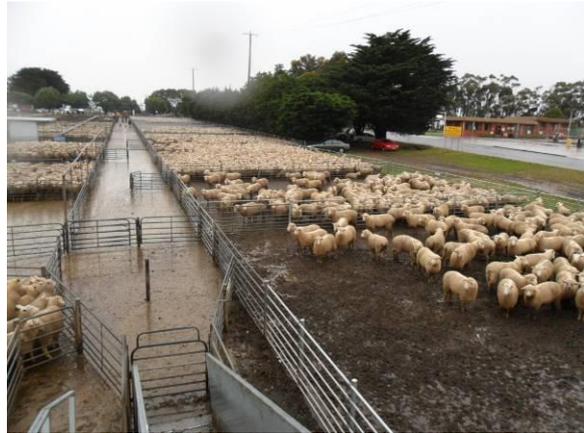
A number of earthen delivery pens are constructed down the eastern side of the selling pens. They are well watered and have the capacity to hold approximately 5,000 adult sheep. The surface has excellent base and can stand significant traffic and wet conditions. Once again, the entry gates do not interfere across the access lane, making the loading of the yards labour intensive. The narrowing of the 'A' lane in the proposed reconstruction, and possible lengthening of the entry gates would make the loading of these pens far more efficient.

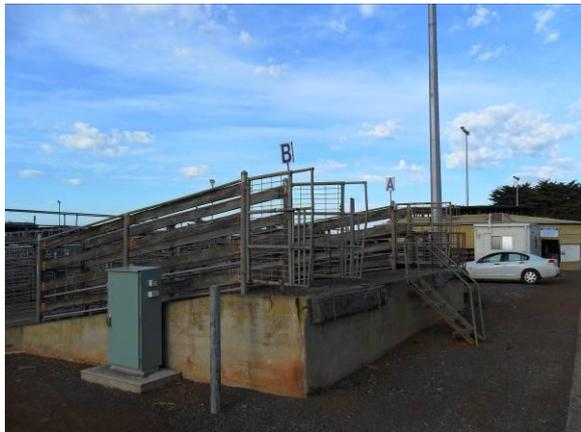
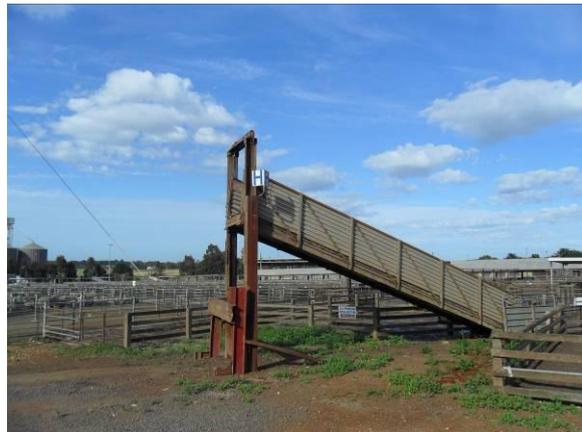
The loading out operation is well catered for by the 5 multi deck ramps at the south end. A small number of trucks utilise the ramp which is situated on the north east corner of the sheep yards. This ramp should be decommissioned when the new northern ramps of the proposed redevelopment are installed as it has some OH&S issues.

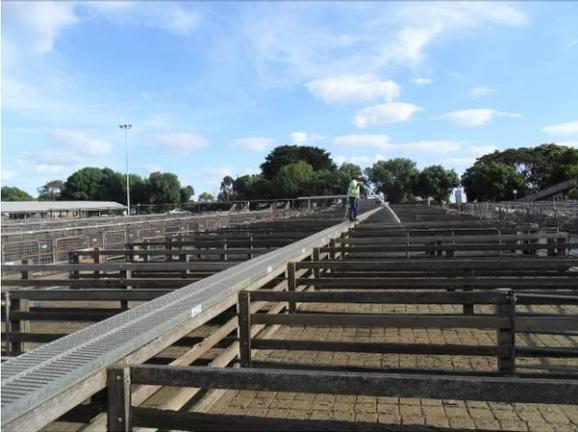
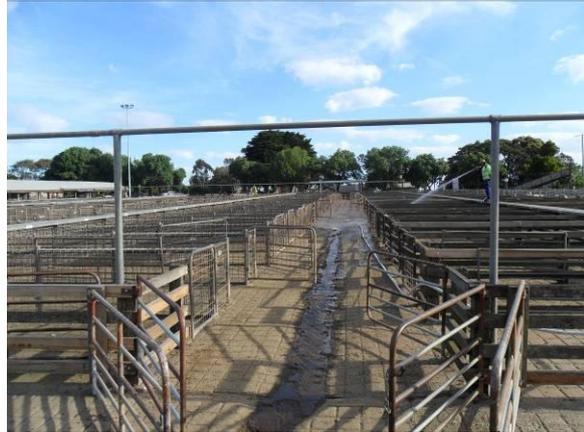
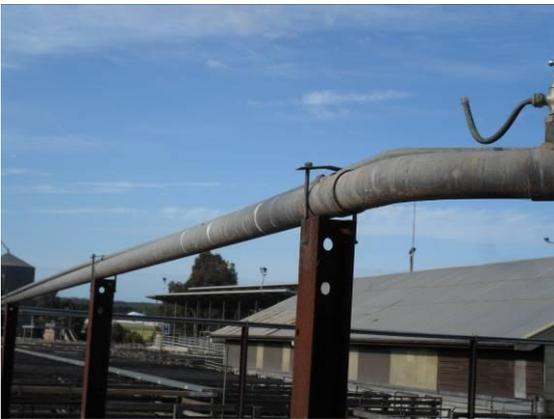
The cleaning of sheep pens is an expensive and labour intensive process. Up to 4 hoses each with an adequate output of approximately 1.5litres/second clean the yards very well. However, the bore water used is quite saline, and will need to be diluted with town supply, collected rainwater or storm water, to be used sustainably in the future.

The reconstruction proposal will enable dry sweeping with a bobcat, as the pens will ‘collapse’ or open up to enable effective mechanical sweeping.

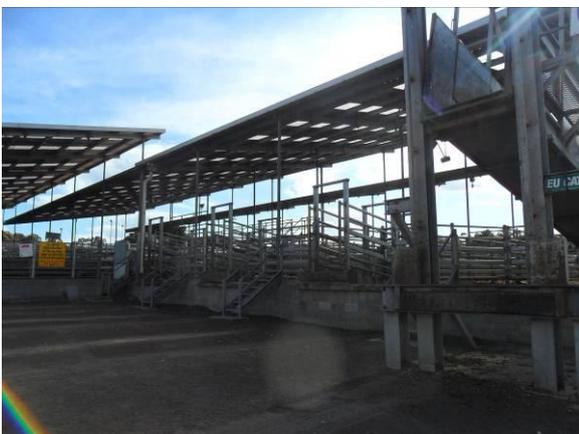
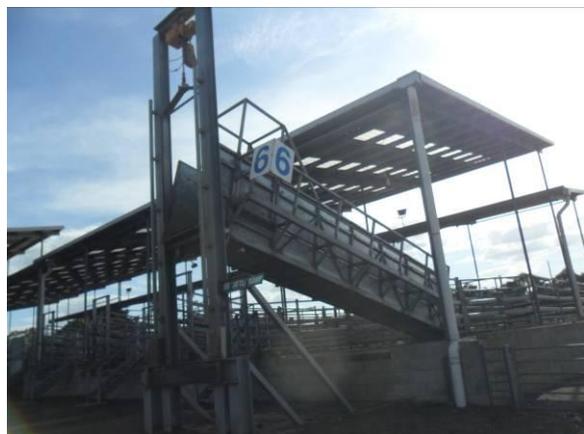
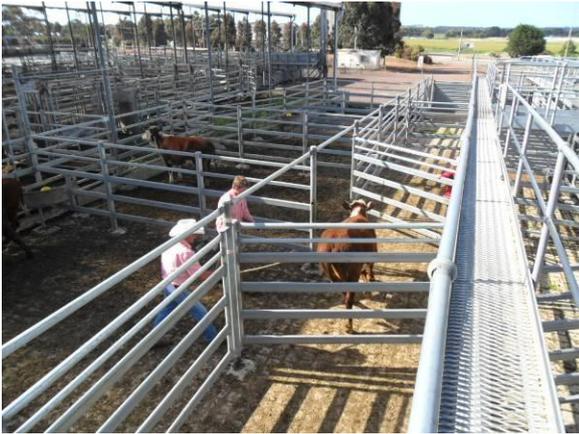
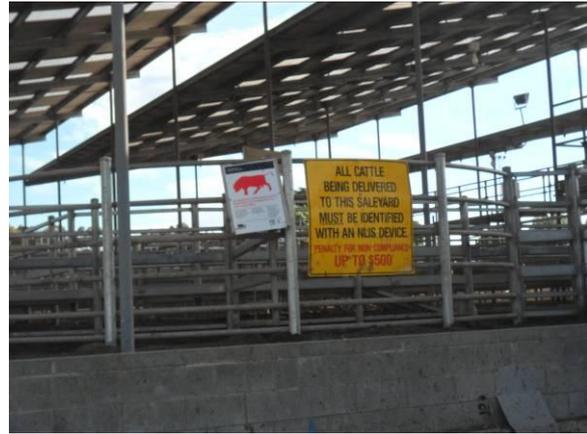
Cattle are unloaded and received at ramps A and B on the northern end of the yards and one multi-deck and three single deck dumps on the southern side of the yards (access from South Boundary Road) All ramps are quite functional, although the truck access to the four southern ramps is tight. The reveal area was reconstructed in 2003, is roofed, well lit and uses soft floor. Construction is of galvanised fencing material and gates for the drafting of mobs interfere in modern fashion. The area works well, although operators are still vulnerable to injury as initial drafting is still being undertaken on the ground, although now with the aid of interfering gates. A recent incident with a senior agent receiving bulls, illustrates the inherent danger of hand drafting without the benefit of separation and pneumatic drafting systems.

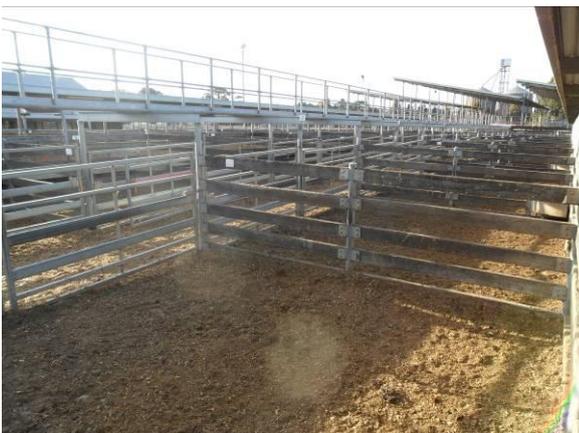
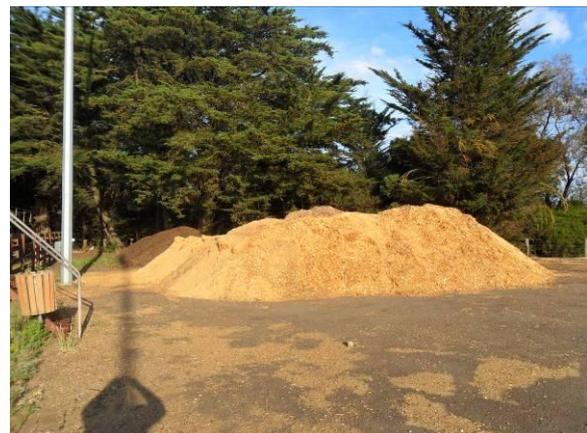
- A buyer standing at the back of the buyers walkway does not have eye contact with the auctioneer.
- The dividing fences between the selling pens are not a gate, as in modern saleyards, and therefore are difficult to clean with a bobcat or mechanical sweeper.

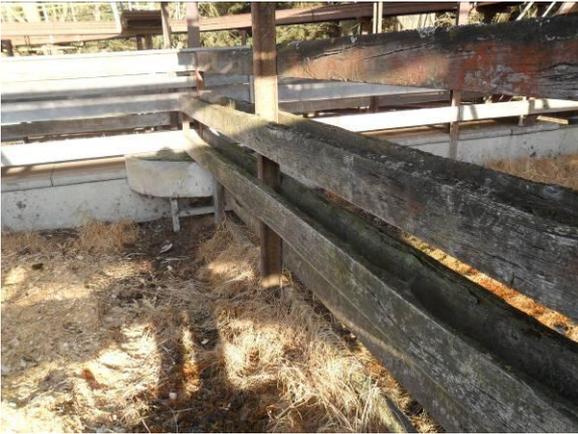
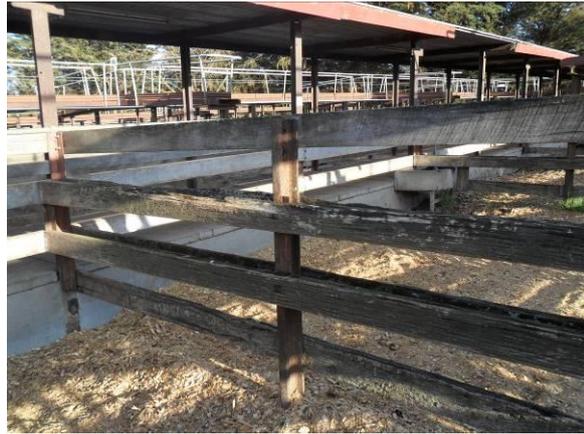
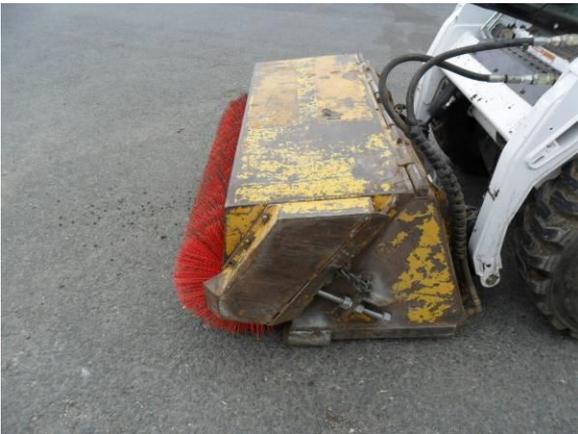
- The timber railing is in fair condition, and will require the provision of a regular replacement program in the future.

Consideration should be given to the provision of replacing the pen dividing fences with gates to facilitate mechanical cleaning in the future.
