REPORT
TO THE
SOUTHERN GRAMPIANS SHIRE COUNCIL
MASTER PLAN
FOR THE
HAMILTON REGIONAL LIVESTOCK EXCHANGE

KATTLE GEAR AUSTRALIA PTY LTD

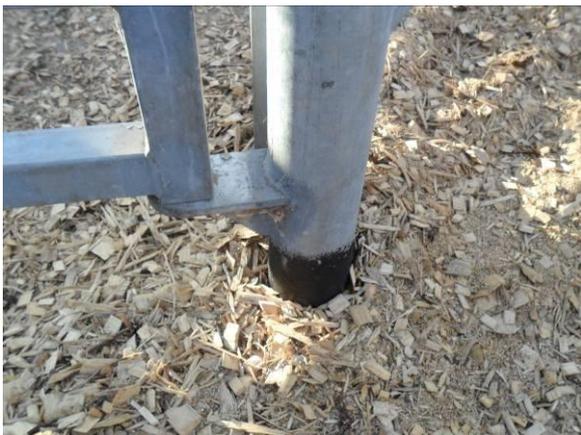
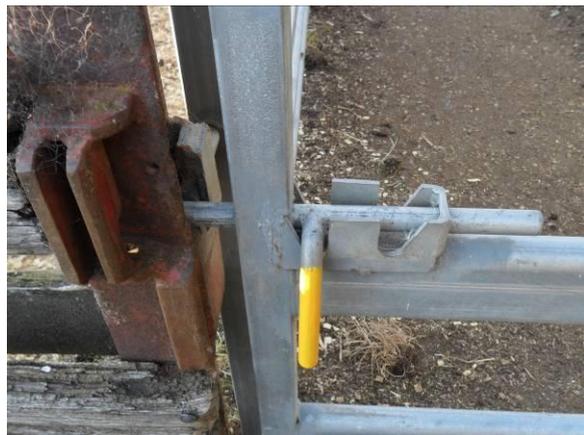
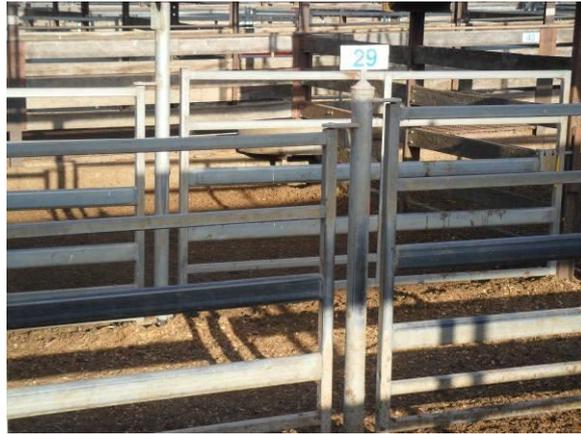
All pens up to 143 have had renovated gates installed to provide safer and better catches and gates which interfere across the lane for easier and safer one man operation. The newer pens have epoxy coating at the intersection with the ground to prevent corrosion.

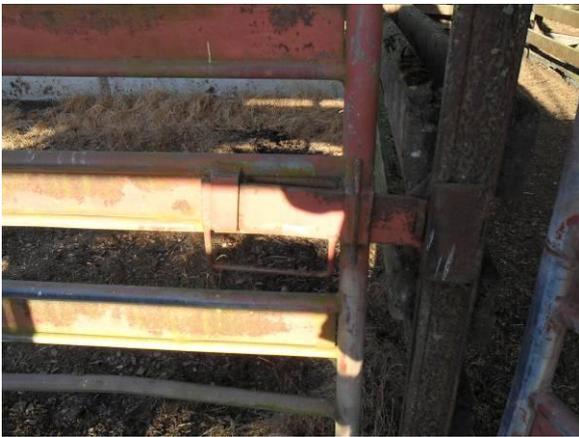
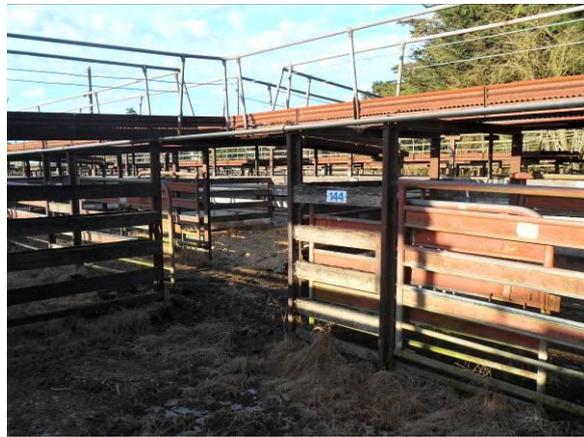
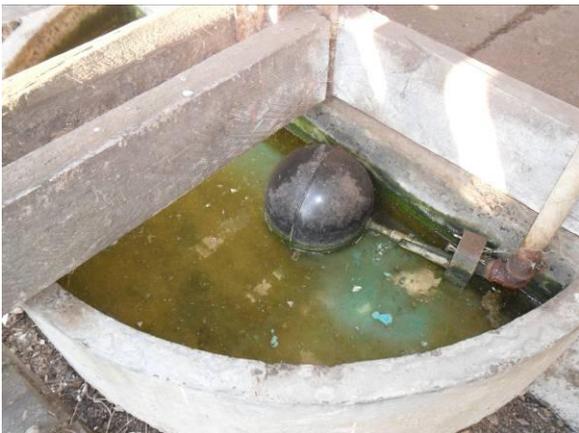
The older pens, 144 to 162 (below) should be progressively upgraded. The gates have catches which are difficult and slow to operate, and do not interfere across the lane. The do however, latch across the lane.

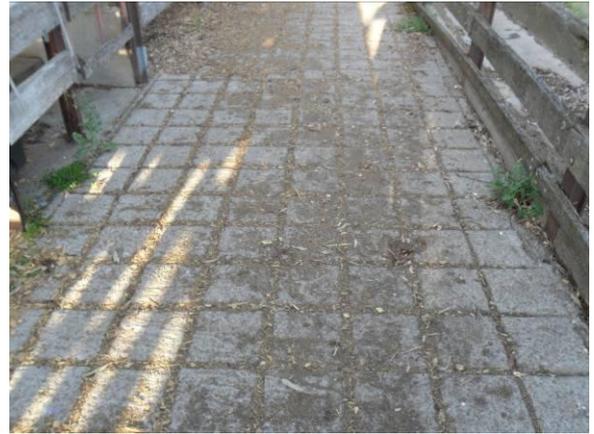
The surface of the pens is concrete, which is in good condition with marking that promotes good animal footing and ease of cleaning.

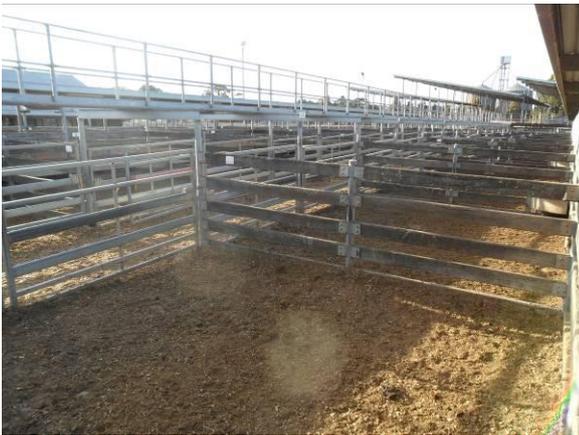
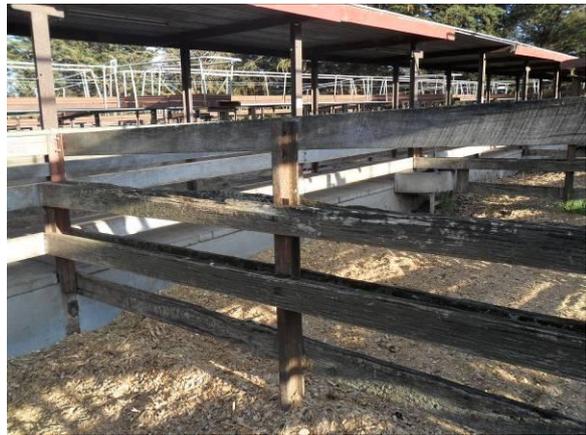
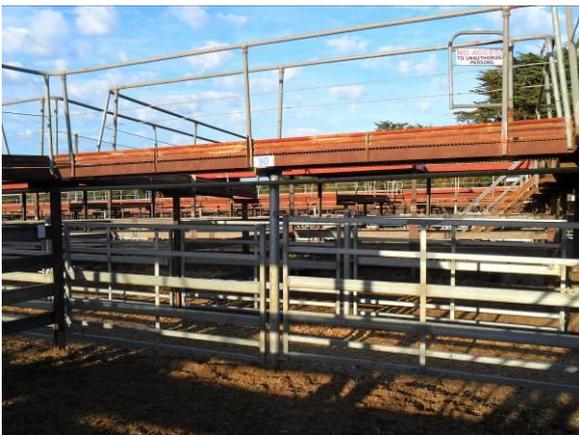
From September to April, wood shavings are placed in the selling pens as a 'soft' floor and the pens are not washed during this period. This has reduced the incidence of lameness experienced in the yards, particularly during the weaner sales in summer.

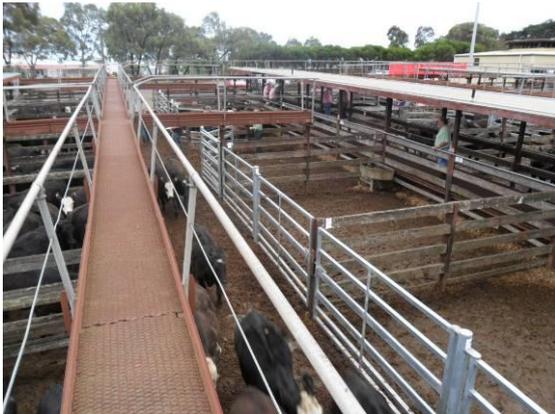
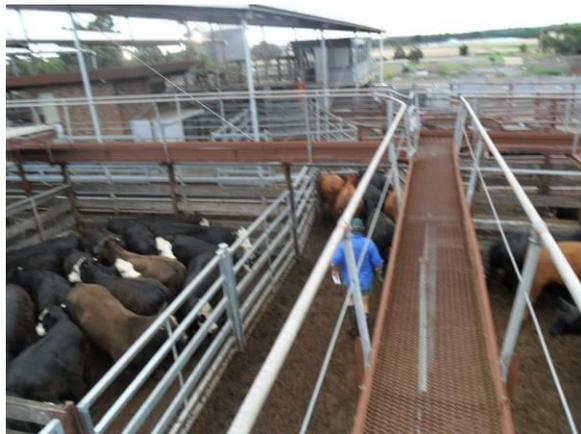
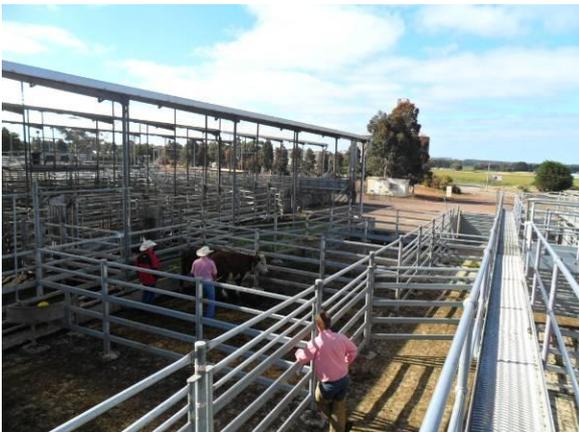
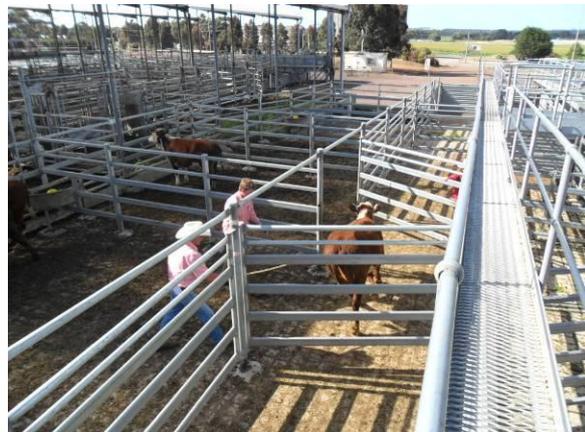
3.3.5 Post Sale weighing/Scales

For fat sales, cattle are moved from the selling pen after sale to the stacking pens prior to having the NLIS tags read as they enter the scale. The system is well designed with the following features:

- Ability to draft small sold lots from pen lots close to the scales, hence reducing the distance travelled by small lots.
- Stack pens which hold small drafted groups close to the scale so that there is continuity of supply to the scale. The stack system allows one man to close off and release the groups. Each

of two lanes is filled and released alternatively so that cattle are only handled or moved once during the process.

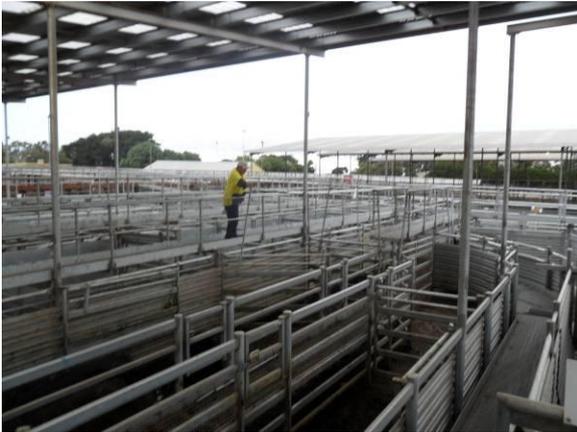
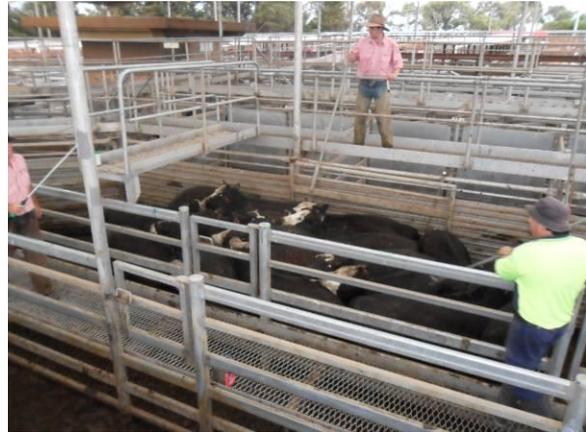
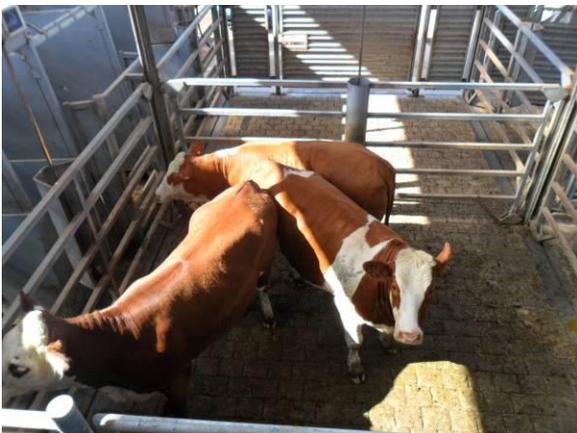
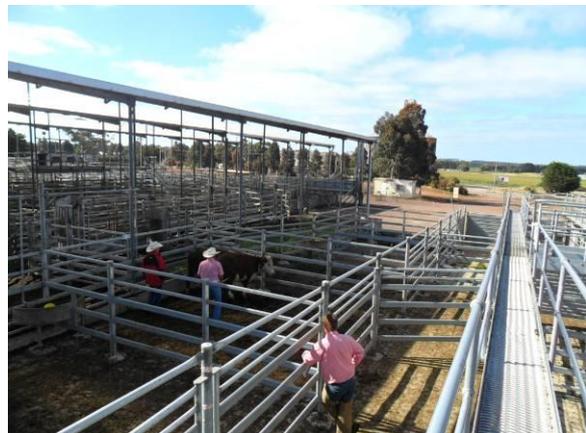
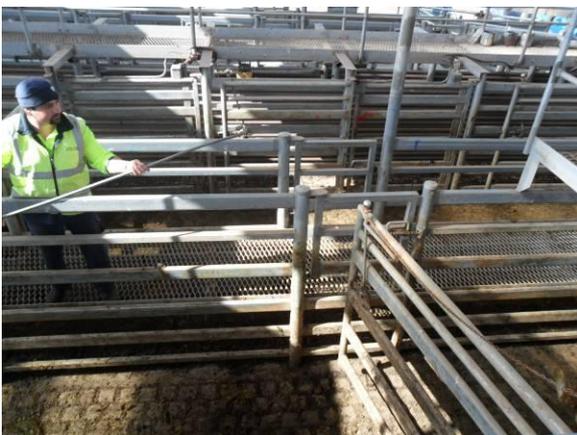
- NLIS readers which the cattle walk through to automatically record ID numbers. These are adjustable for width. The Aleis type employed is not as ‘flow friendly’ as the latest laneway readers, which are up to two metre wide, and therefore promote better flow.
- An adjustable cattle scale which accommodates small to very large lots via central partitions. The scale is also user friendly in that in the case of a ‘no reader’ animal, the animal can be taken off the scale to the side, and the weigh lot adjusted.

The central area between the stack pens was designed as a remote draft operated by pneumatics and remote control pads to separate the handler and the cattle. The consultant has not seen the

system in operation as it is no longer used, the agents preferring to draft weigh lots from the same pen on the ground.

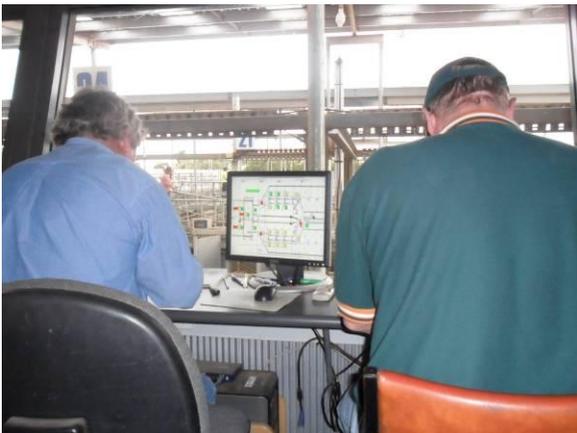
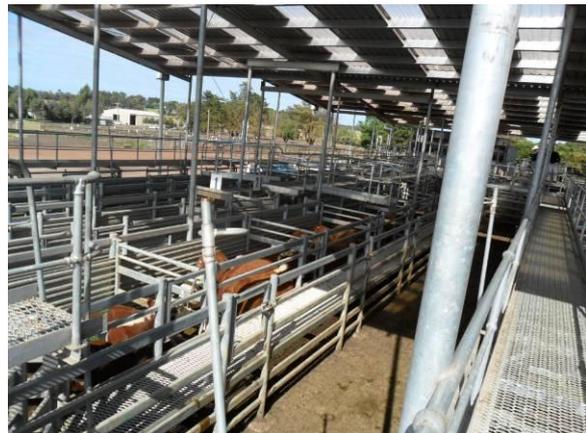
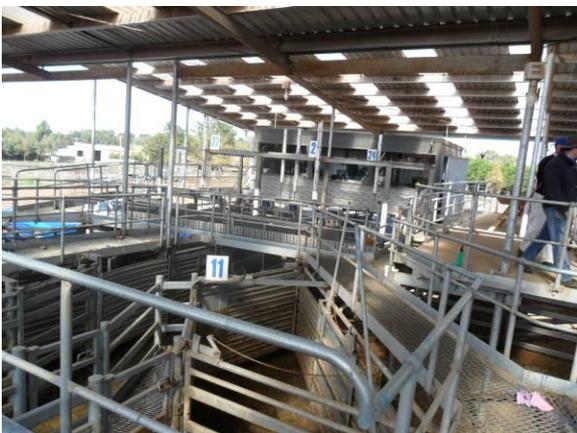
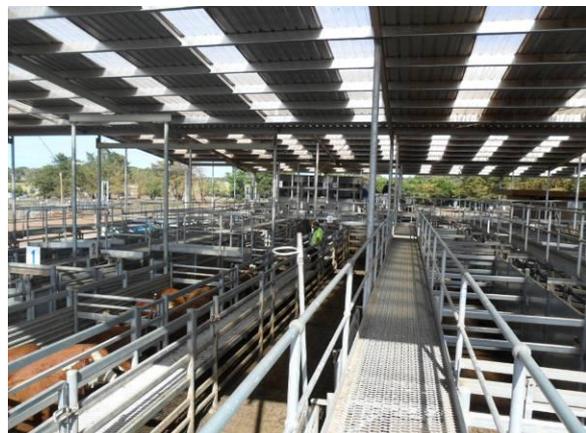
- The scale house is elevated (about 2.5m at floor level), and straddles the exit from the scales. The scale operator has excellent vision to count the number of cattle on the scale, monitor the operation of pneumatic entry and exit gates and control an exceptionally safe and effective work space. An interactive touch screen aids in the control process.

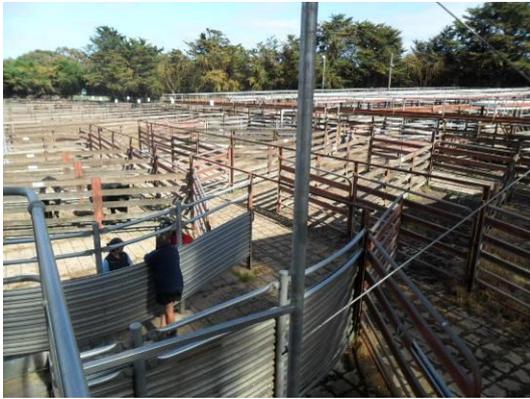
- The delivery process post weighing is initiated by the release of the cattle of off scale from within the scale house. The delivery staff are advised of the ownership at destination of the lot by public address.

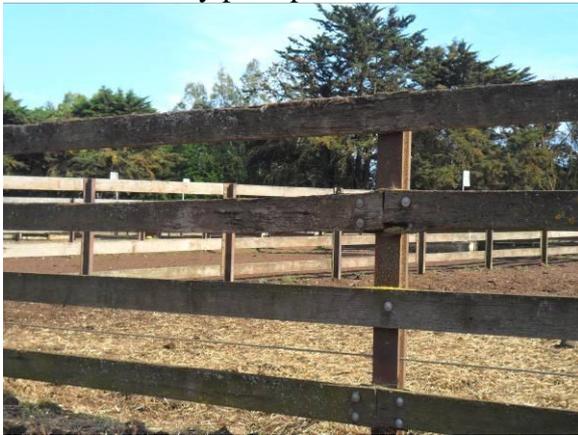
- The delivery pens/paddocks are extensive numbering some 50 pens

- . Access is via laneways, some of which are concreted. The fencing of the pens/paddocks is old and requires considerable maintenance to continue to be effective.

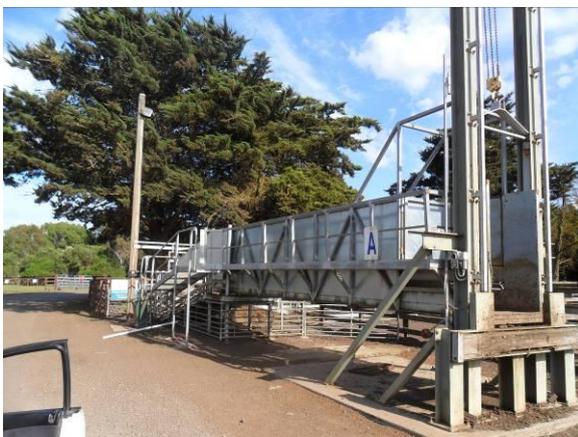
The ramps are substantial, well built and safe additions to the yards. Unfortunately, there appears to be a poor understanding of walkway design requirements to comply with Australian Standards (AS1657). The walkways are too narrow, at around 450mm, and should be widened when the opportunity arises.

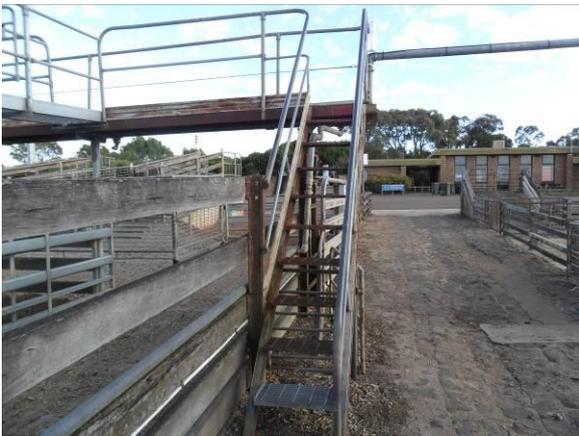
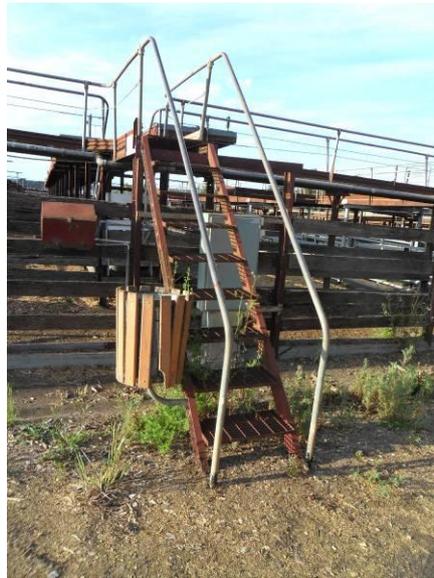
The cattle yards are accessed from the northern end. The northern most overhead walkway can be accessed from either of 2 stairways, one at the eastern end near the manager's office, or the other to the west towards the Portland Road access.

Neither stairs meets the requirements of Australian Standards (AS 1657). The risers are too high, there are no step returns, the width of the stairs is too narrow and there is no knee rail or kick rail.

It is recommended that a suitably qualified consultant be retained to review and provide detailed design of the necessary upgrades of all stairways and walkways on the site in order that these safety deficiencies are addressed properly and a series of management protocols are developed.

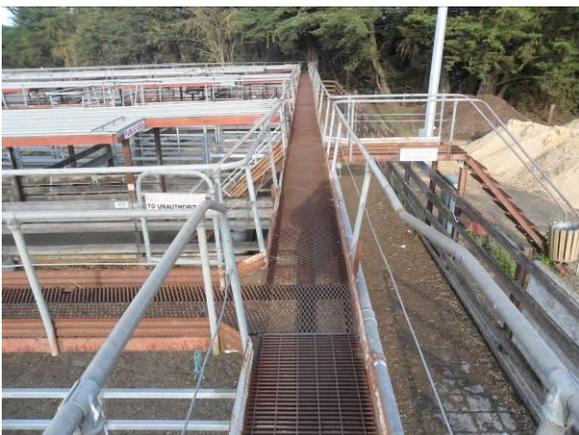
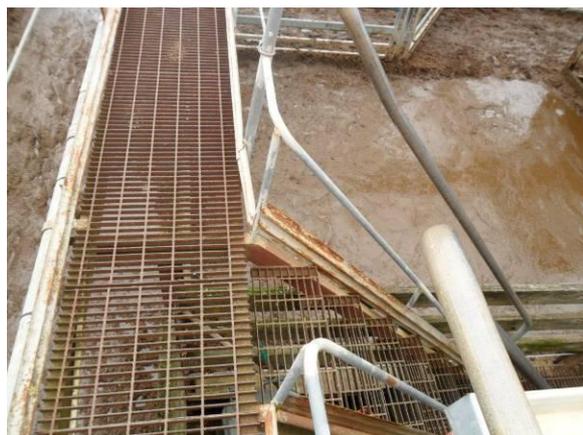
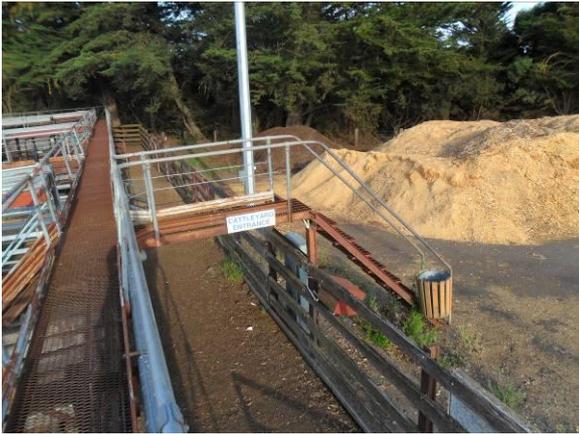
- Once the patron is on the elevated walkway, a single person width walkway runs in an east west direction. Many of the stairways which lead from this walkway to the buyers walkway do not have platforms before the stairs descends. These descending stairs do have the required knee rails and kick rails, however, the treads and rises do not comply.

- The east west walkway also fails to meet standards with regards to hand rail heights at the western end, and possibly with regard to knee rail compliance.
- The alternative access to the buyers walkway is at ground level, through the rotunda, across the northern east to west cattle laneway, through a self closing personnel gate and up a short stairs onto the buyers walkway.

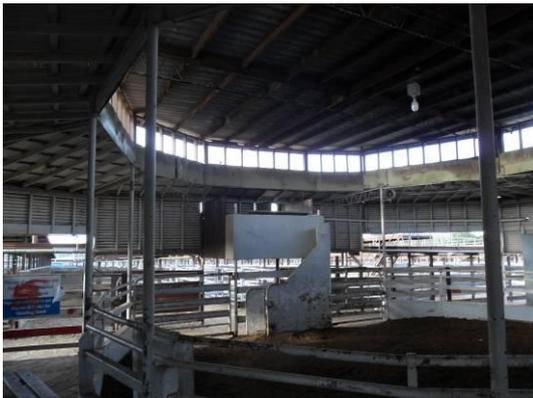
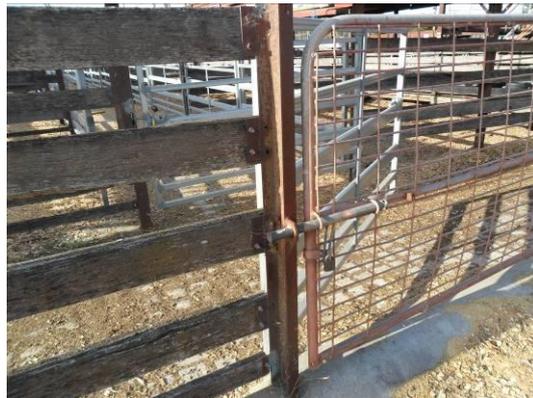
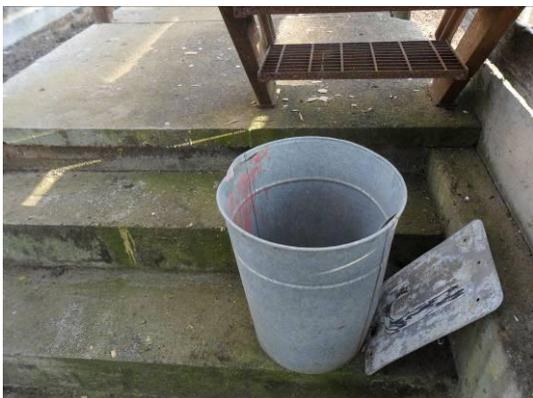
- This access can be slippery with the risk of being splattered with manure. Modern saleyards keep patron access and cattle totally separated for obvious risk reasons. In the case of Hamilton, and particularly during large weaner sales, the movement of cattle into this northern laneway

needs to be banned, or actively managed while patrons are in the yards, and accessing the buyers walks.

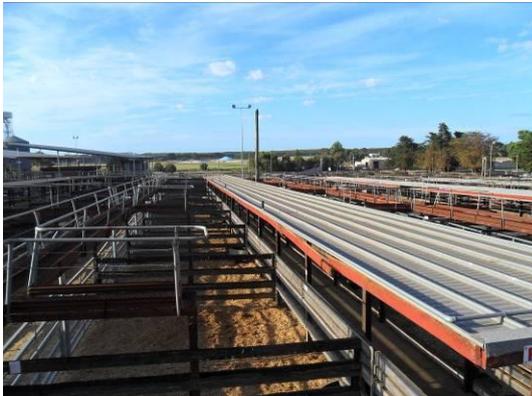
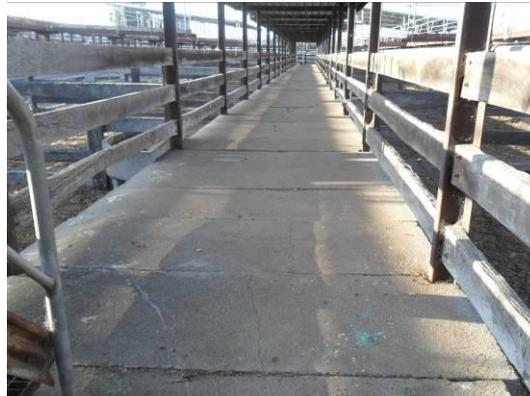
- The buyer walkways are roofed and the floor is of pre cast concrete.

Some urgent maintenance is required to repair fascia's in the buyers walkway roof and there is some unevenness between the joins of the pre cast slabs that could be improved to reduce risk.

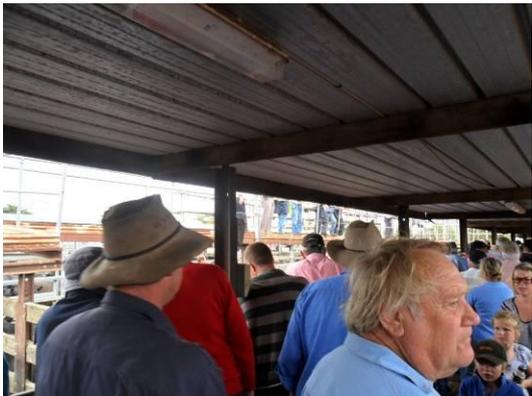
- A longer term issue is that when a patron is standing at the far side of the elevated buyers walkway, the overhang of the roof stops eye contact with the selling agent on some of the auctioneers walkways.

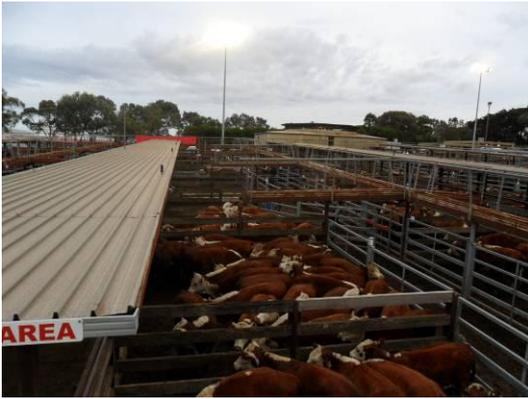
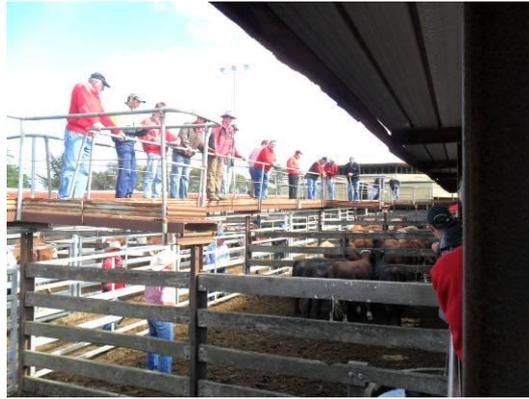
3.3.10 Auctioneers Walkways

- The walkways run parallel with the buyers walkways in a north south direction.
- They are variously placed on the fence posts of one side of the cattle lane or central in the lane.

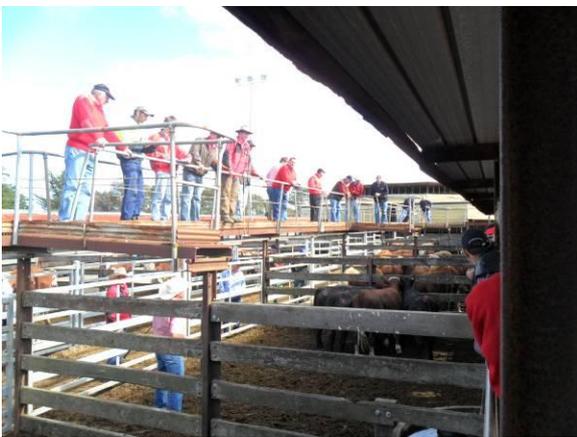
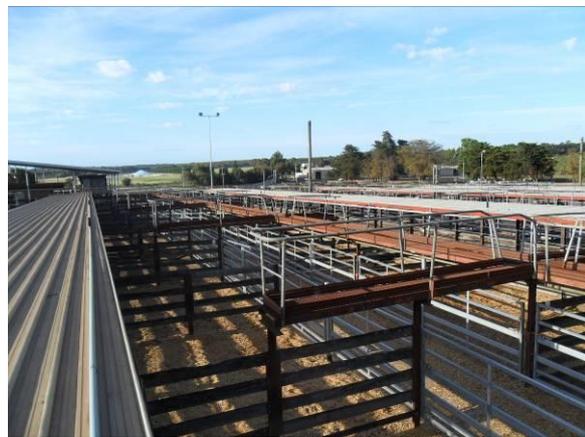
- Some lanes have nibs off the north south main run to allow the auctioneers to get closer to the bidders.

In practice, the agents do not use these nibs regularly. Many of the handrails are not high enough to meet code requirements. Platforms on junctions of through walkways and stairs need to be provided and possibly computations need to be undertaken to ensure the structural integrity of the scantlings used which are not standard relative to AS 1657.

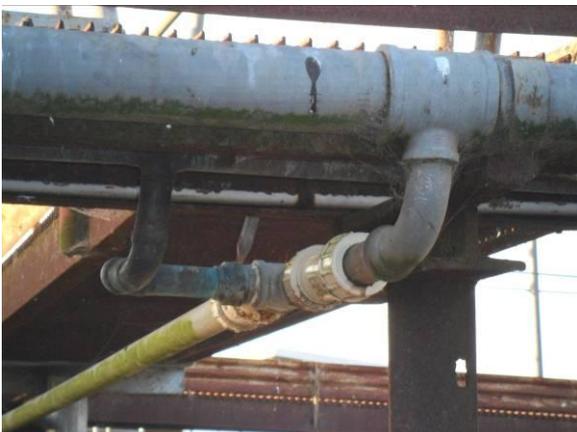
- The supply of wash down water to these areas is achieved by the attachment of the water supply to the underside of the auctioneers walkways

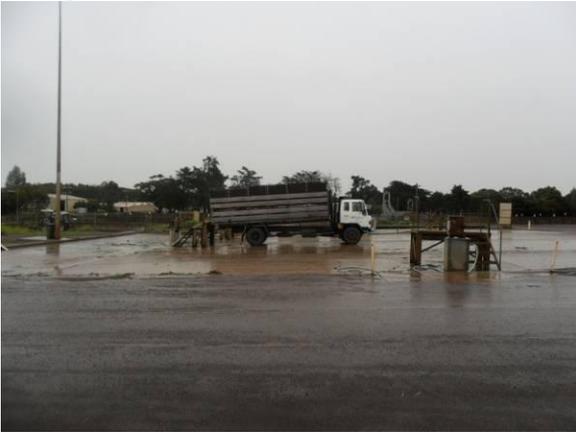
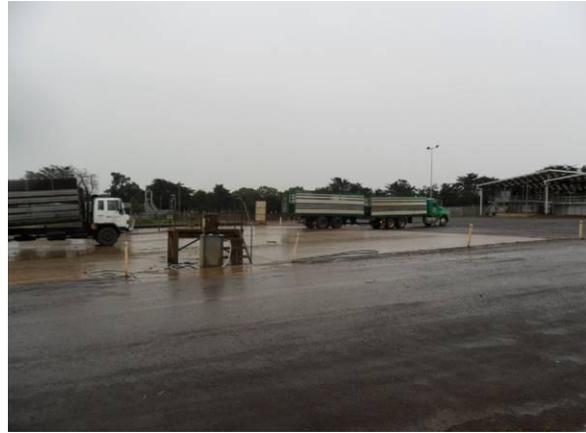
- The pressure is ideal with a water flow rate of about 1.5litres/second per hose
- The area is well lit.
- The facility is well set up, in excellent state of repair and well patronised by transport operators.

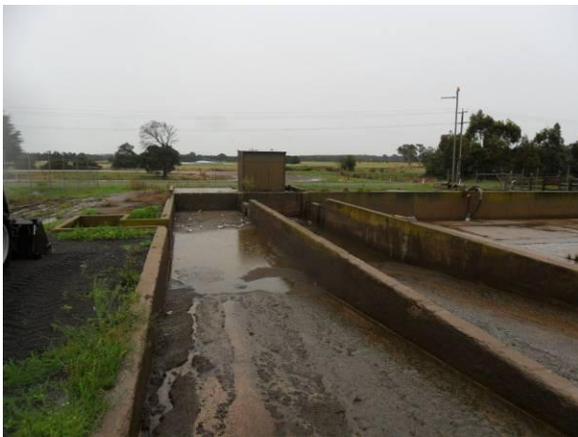
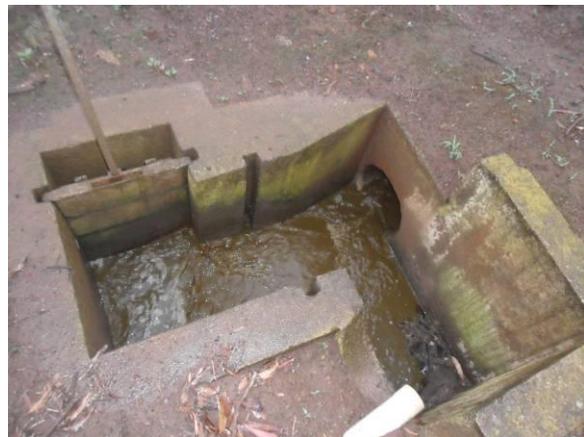
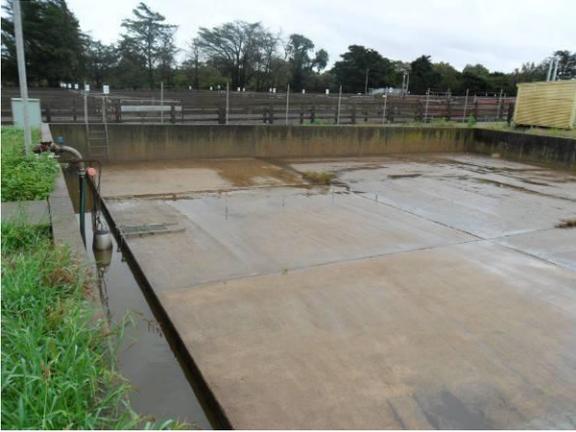
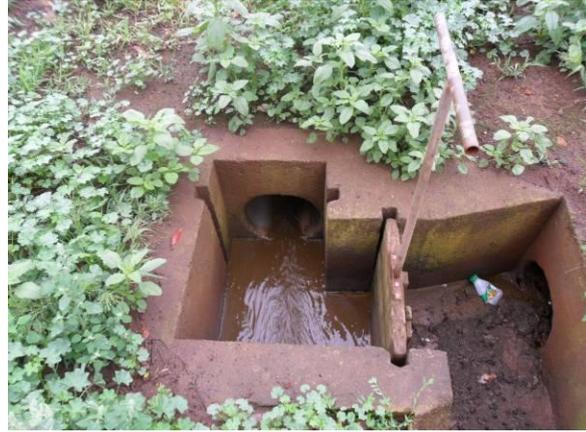
3.4.4 Effluent Treatment Facility

Wash water and storm water are collected at the southern end of both the sheep and cattle yards. From here the effluent is directed to two diversion weirs, one at the south west corner of the sheep yards, with the second servicing the cattle yards located to the north of the solids storage area.

- These weirs are designed to direct all liquid flows to the selling pit/effluent treatment when the yards are dirty (whether yards are being washed, or there is rainfall). Once the yards are clean, the directional slide is positioned to allow any further rainfall to divert to the local storm water system.

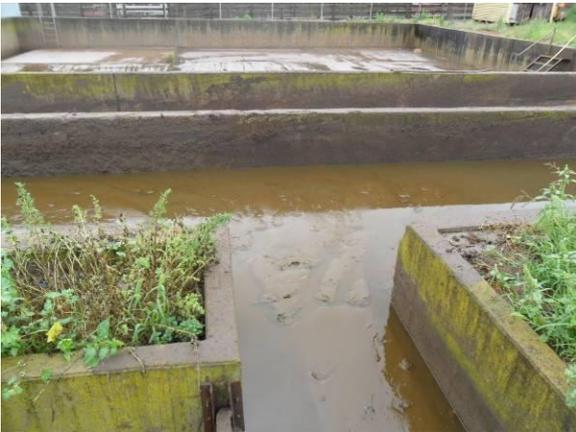
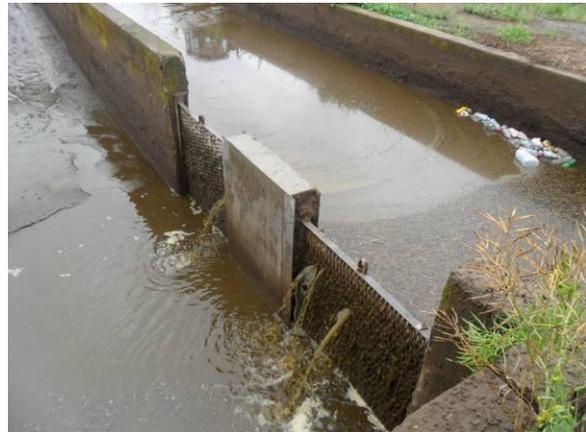
- Effluent entering the primary and secondary pits flows to a pumping station from where it is pumped to the aerobic dam in the irrigation paddocks to the west of Portland road.
- The capacity of the adjacent holding basin is sufficient to accommodate a high intensity storm, and the consultant has been advised capacity was adequate for all previous storm water events.
- Sludge collected in the settlement pits is removed to the drying area above the holding basin, where any liquid can drain back into the basin.

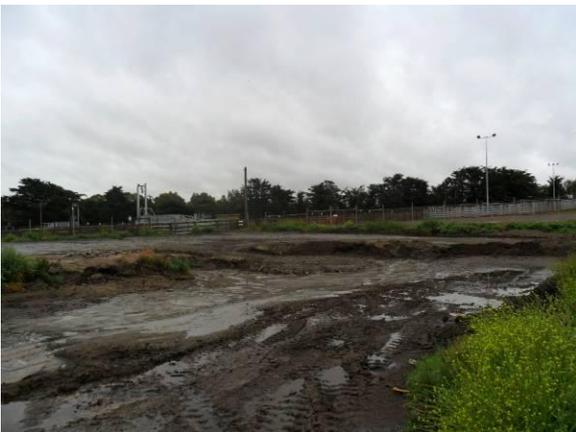
- The front end loader provided can struggle to handle the weight of the wet sludge on the soft surface of the drying bay.
- Concrete surfacing of this area would assist the ease of the de sludging process.
