HERITAGE PLACE

NAME OF PLACE: BANK OF VICTORIA (FORMER)

ADDRESS/LOCATION OF PLACE: 40 Martin Street PENS HurST

STUDY NUMBER: 154

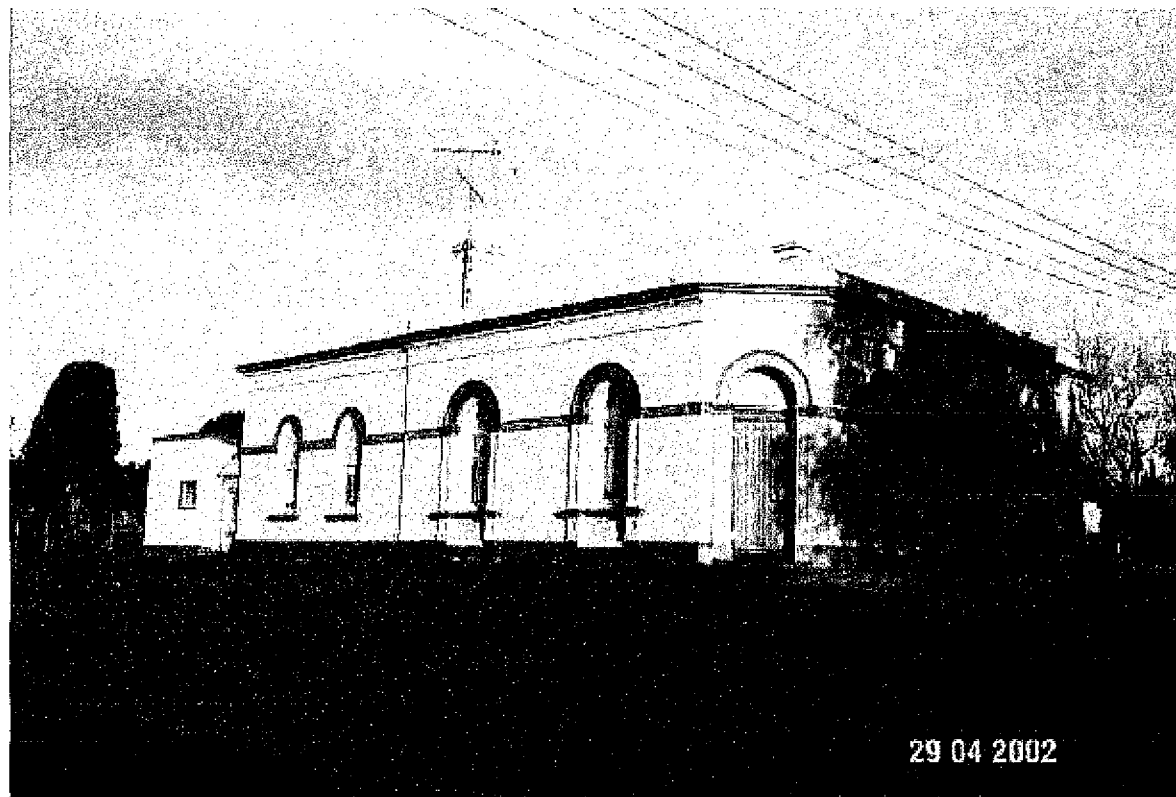
Image Date: 29/04/02

Former Bank of Victoria, 40 Martin Street, Penshurst.

The former Bank of Victoria is a single storey building, effectively symmetrical about the corner entrance, built of rendered brick (or bluestone?). The façade uses an arcuated system of simulated structure. The parapet is very plain behind which there is low pitched hipped corrugated iron roof.

The former Bank of Victoria survives reasonably intact, and is in good condition.
