HERITAGE PLACE

NAME OF PLACE: COLONIAL BANK (FORMER)

ADDRESS/LOCATION OF PLACE: Lynch Street BRANXHOLME

STUDY NUMBER: ~~0522~~ 207 **HERITAGE OVERLAY NUMBER:**

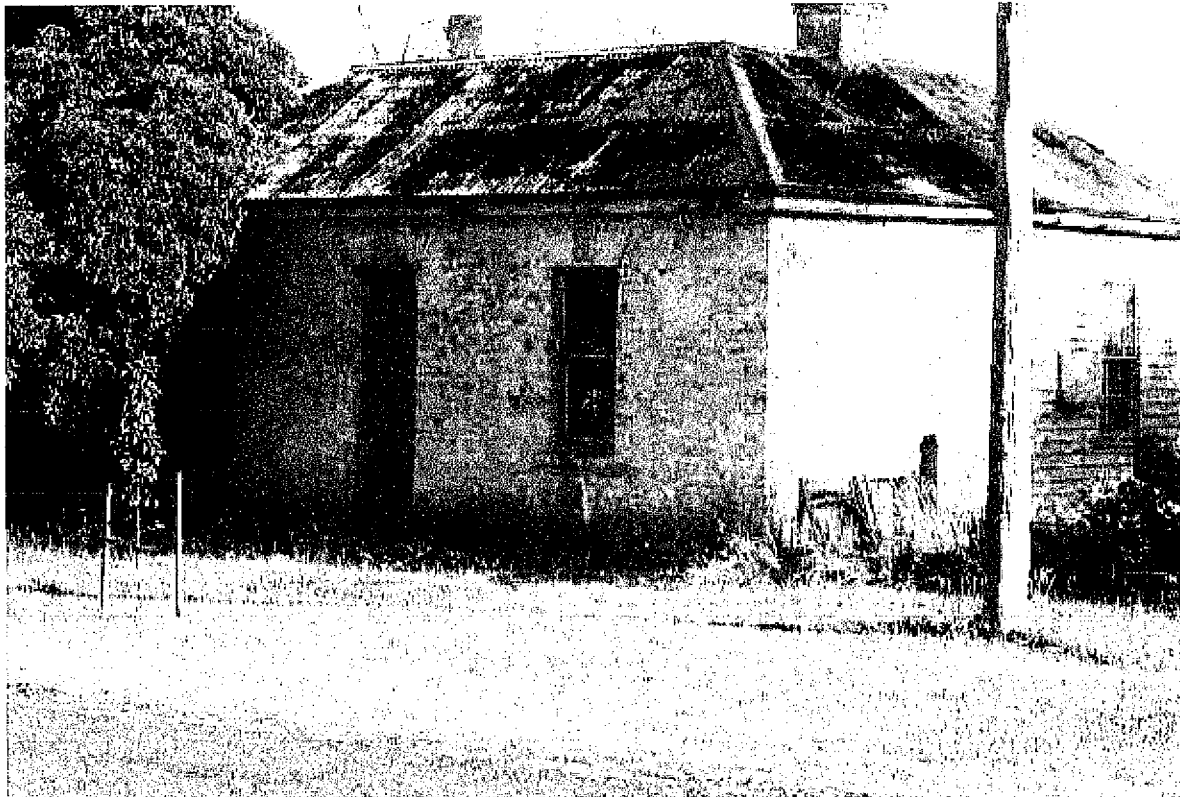
Image Date: 31/01/02

Colonial Bank (former), Lynch Street, Branholme.

A single storey, symmetrical brick building of traditional house form, now painted, which formerly had a timber and cast iron verandah across the western or garden elevation. The northern half of the verandah was enclosed with weatherboards to dado height and sliding glazed sashes above. The roof is hipped with an M-shaped profile and is covered in corrugated iron. The front windows are 2-paned double hung sashes, while the side and rear windows are 12-paned double hung sashes. The two chimneys are located opposite the front windows. The rear half of the house (or its extension) is in weatherboard with the roof continued in the same materials, form and pitch.

The building is in poor condition

low degree of integrity
